Lake Hayward Second Beach Park Hazard Identification and Risk Assessment

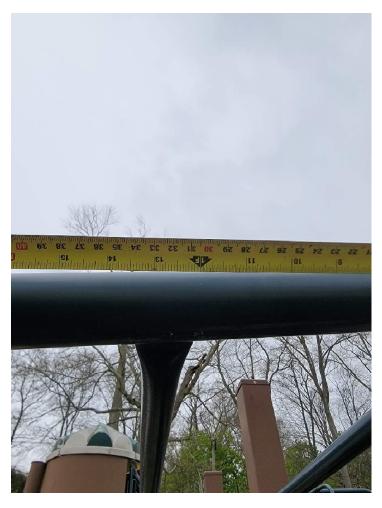
Hazard Identification	Applicable Standard Number	Applicable Standard Text	Injury Risk	Steps to Mitigate
Fall height is 87"	ASTM 1487 – Section 8.3.3	The maximum height of upper body devices for use by 2 through 5-year-olds shall be no greater than 60 in. (1524mm), measured from the center of the grasping device to the top of the protective surfacing below. The maximum height of upper body devices for use by 5 through 12-year-olds shall be no greater than 84 in. (2130 mm). Upper body equipment intended for users in wheelchairs shall have grasping devices no greater than 54 in. (1370 mm) above the accessible surface (see Fig. A1.50).	Fall from a height greater than the critical height of the surfacing can cause life threatening or debilitating injury.	Lower overhead ladder or add surfacing to bring into compliance.

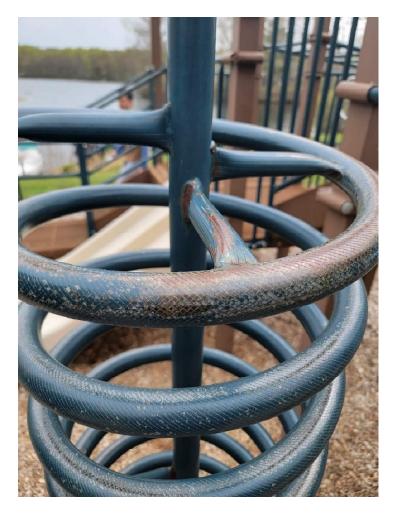
Hazard Identification	Applicable Standard Number	Applicable Standard Text	Injury Risk	Steps to Mitigate
General rust and wear	ASTM 1487 - General	N/A	Rusty parts can pose a cut/abrasion hazard. Also, potential structural damage.	Sand down rust and repaint.

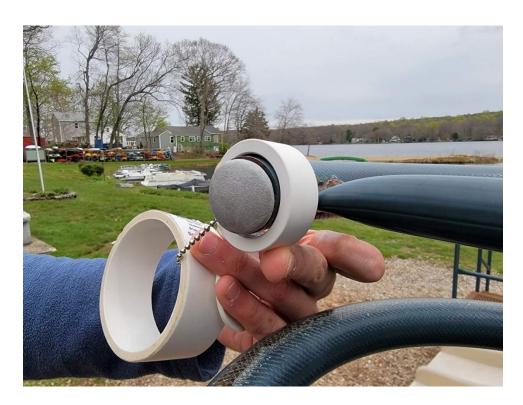
Hazard Identification	Applicable Standard Number	Applicable Standard Text	Injury Risk	Steps to Mitigate
General rust and wear	ASTM 1487 - General	N/A	Rusty parts can pose a cut/abrasion hazard. Possible structural damage where horizontal bars meet upright post.	Sand down rust and repaint

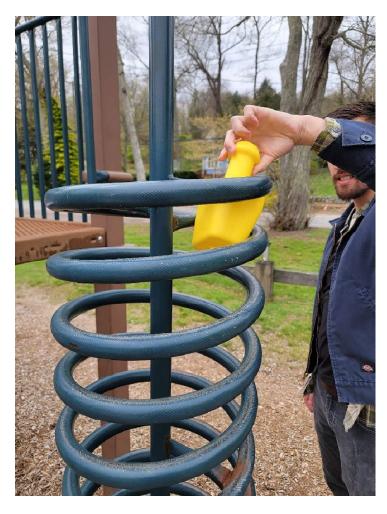
Hazard Identification	Applicable Standard Number	Applicable Standard Text	Injury Risk	Steps to Mitigate
Top of climbing spiral fails protrusion test for child's eye socket.	ASTM 1487 – Section 6.3	Protrusions—There shall be no protrusions on public play equipment. Three projection test gauges (shown in Fig. A1.10) and a projection gauge (shown in Fig. A1.11) are required to determine whether projections are protrusions. Their use is described in this section.	Child could be impaled.	Find a way to increase diameter or remove the play feature.

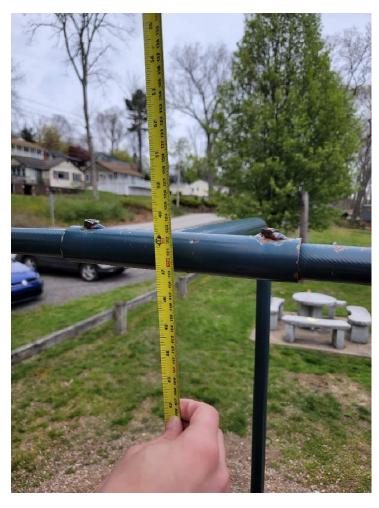
Hazard Identification	Applicable Standard Number	Applicable Standard Text	Injury Risk	Steps to Mitigate
Climbing spiral entrapment hazard.	ASTM 1487 – Section 6.1	Head and Neck Entrapment—Public playground equipment shall be designed and constructed or assembled so that any accessible opening shall meet the following performance requirements to reduce the risk of accidental head or neck entrapment by either a head-first or feet-first entry into the opening. Openings between the protective surfacing and the bottom edge of the equipment (that is, rails, platforms, steps, and so forth) are exempt from this requirement as indicated by Fig. A1.1.	Child can fall in the spiral climb and get stuck causing strangulation.	Remove play feature.

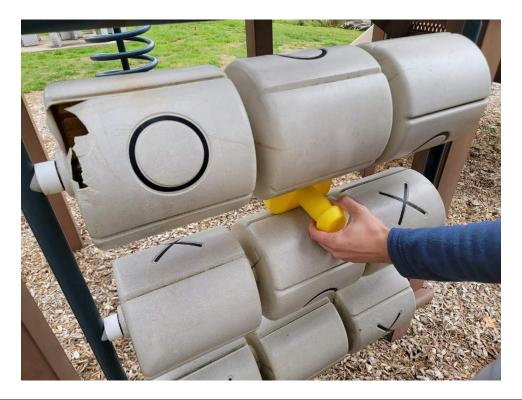
Hazard Identification	Applicable Standard Number	Applicable Standard Text	Injury Risk	Steps to Mitigate
Area above tic tac toe feature is an entrapment hazard.	ASTM 1487 – Section 6.1	Head and Neck Entrapment—Public playground equipment shall be designed and constructed or assembled so that any accessible opening shall meet the following performance requirements to reduce the risk of accidental head or neck entrapment by either a head-first or feet-first entry into the opening. Openings between the protective surfacing and the bottom edge of the equipment (that is, rails, platforms, steps, and so forth) are exempt from this requirement as indicated by Fig. A1.1.	Risk of strangulation.	Add filler panel or remove play feature.

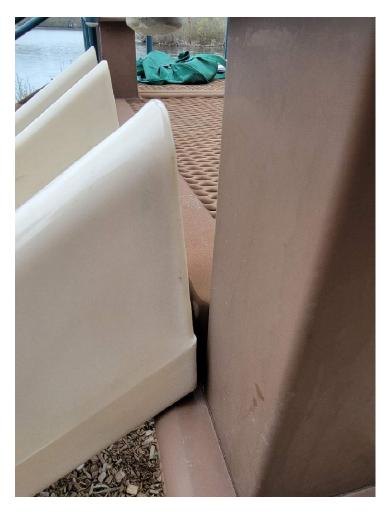
Hazard Identification	Applicable Standard Number	Applicable Standard Text	Injury Risk	Steps to Mitigate
Top of slide fails protrusion test for child's eye socket.	ASTM 1487 – Section 6.3	Protrusions—There shall be no protrusions on public play equipment. Three projection test gauges (shown in Fig. A1.10) and a projection gauge (shown in Fig. A1.11) are required to determine whether projections are protrusions. Their use is described in this section.	Child could be impaled.	Find a way to increase diameter or remove the play feature.

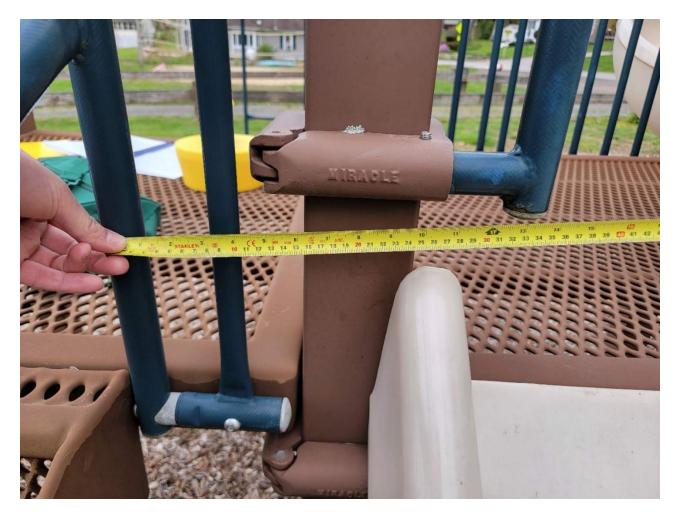
Hazard Identification	Applicable Standard Number	Applicable Standard Text	Injury Risk	Steps to Mitigate
Area where slide meets structure has an entanglement hazard which could catch on a child's clothing.	ASTM 1487 – Section 6.4.1.2	Slides shall be constructed in such a manner as to provide a continuous sliding surface (roller slides exempted) and shall minimize the likelihood of entanglements.	Child could be strangled.	Fill the gap to eliminate entanglement hazard.

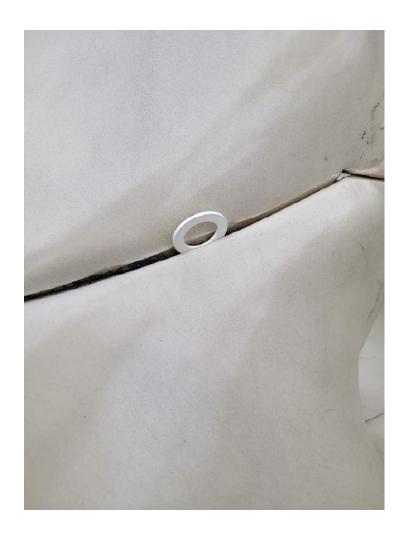
Hazard Identification	Applicable Standard Number	Applicable Standard Text	Injury Risk	Steps to Mitigate
Bolts connecting the slide to the top of the structure currently fail the requirements for slide entanglement.	ASTM 1487 – Section 6.4.1.1	A projection that meets both of the following requirements is an entanglement hazard: (1) One of the three projection gauges (see Fig. A1.10) passes over the projection and contacts the initial surface. (2) The projection extends perpendicular (65°) from the initial surface more than 0.12 in. (3.0 mm). The thickness of the projection gauge (see Fig. A1.11) may be used to measure the 0.12 in. (3.0 mm) extension	Child could be strangled.	Replace bolts with lower profile bolts.

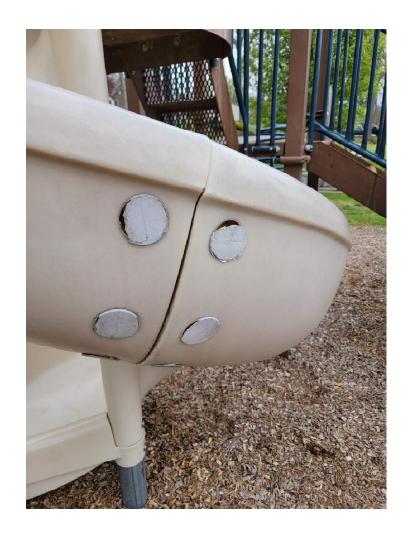
Hazard Identification	Applicable Standard Number	Applicable Standard Text	Injury Risk	Steps to Mitigate
Sliding surface contains entanglement hazard.	ASTM 1487 – Section 6.4.1.2	Slides shall be constructed in such a manner as to provide a continuous sliding surface (roller slides exempted) and shall minimize the likelihood of entanglements.	Child could be strangled.	Fill gap in slide.

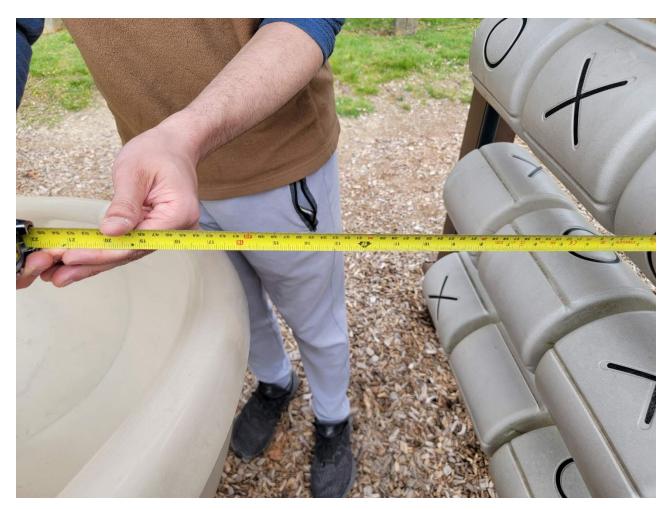
Hazard Identification	Applicable Standard Number	Applicable Standard Text	Injury Risk	Steps to Mitigate
Spiral slide has broken plastic.	ASTM 1487 – General	N/A	Broken plastic has sharp edges which can pose a cut hazard. Item can also trap water which attracts mosquitos.	Find replacement part or cover broken plastic in some way.
