# ***INSPECTION REPORT***

## ***LAKE HAYWARD DAM CT DEEP #04105***

HAYWARDVILLE ROAD  
HAYWARD BROOK  
EAST HADDAM, CONNECTICUT

DECEMBER 2019

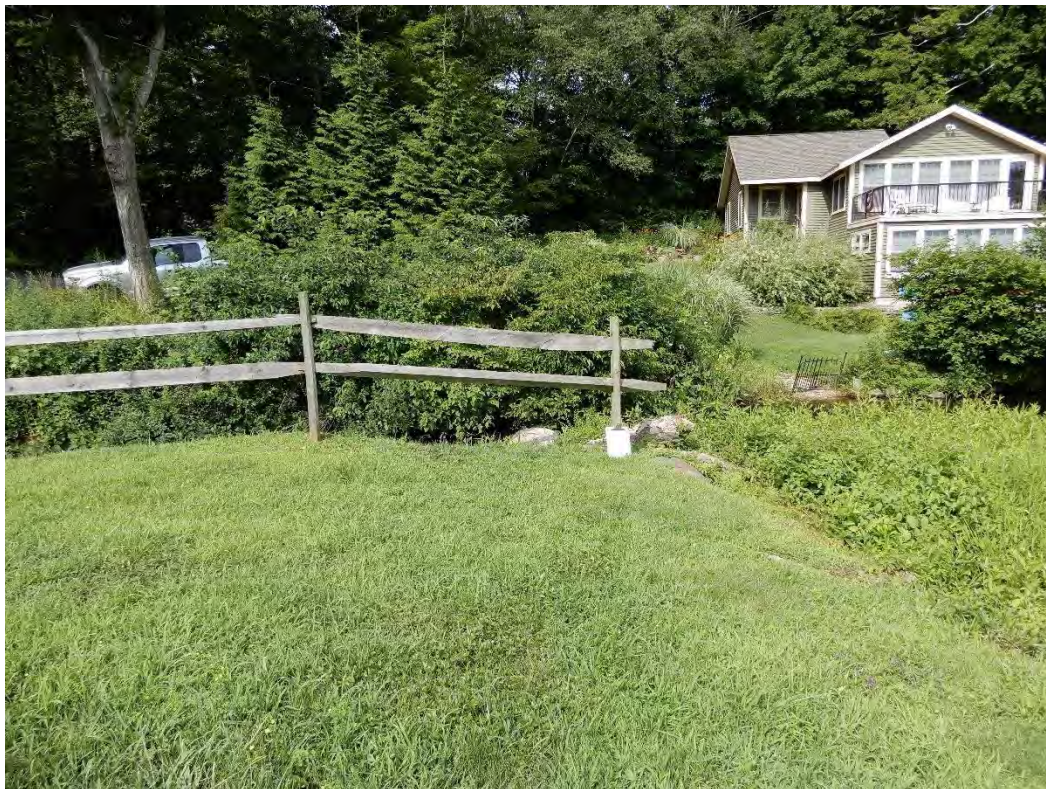
Photo 3a – The right upstream embankment face, prior to removal of vegetation completed between the two inspection dates.

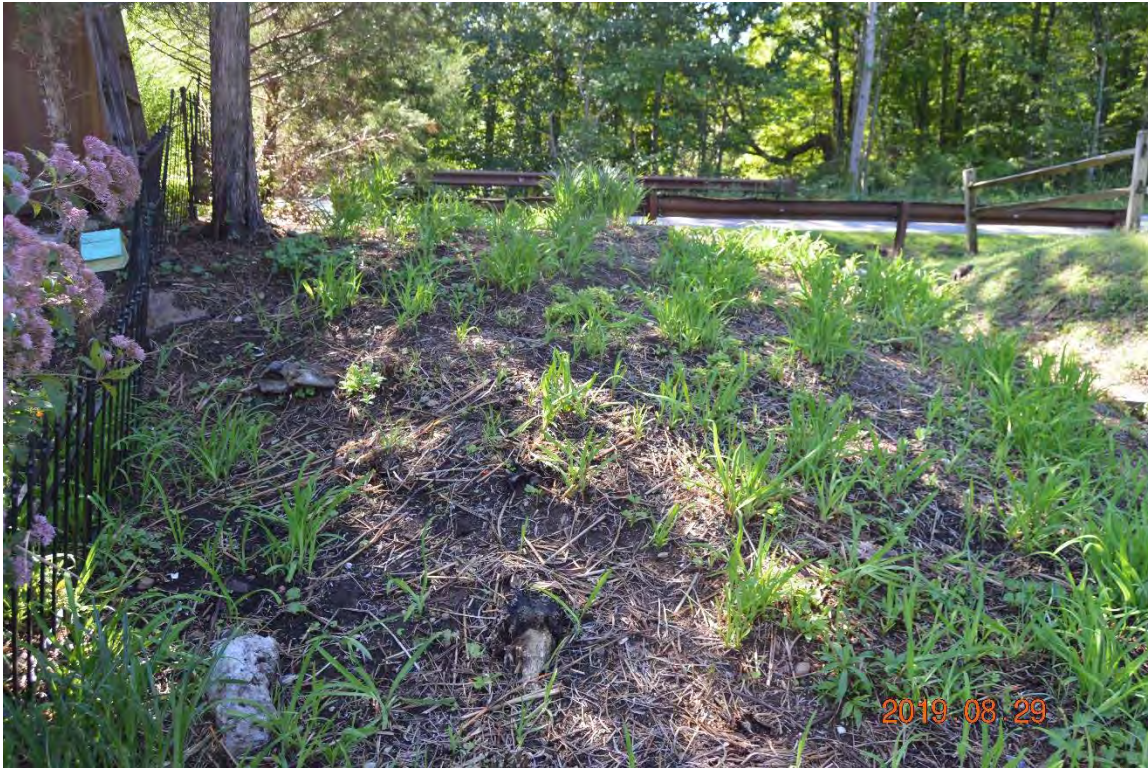
Photo 4b – The short upstream embankment section to the left of the left side spillway. Care must be taken to establish a good grass cover here.

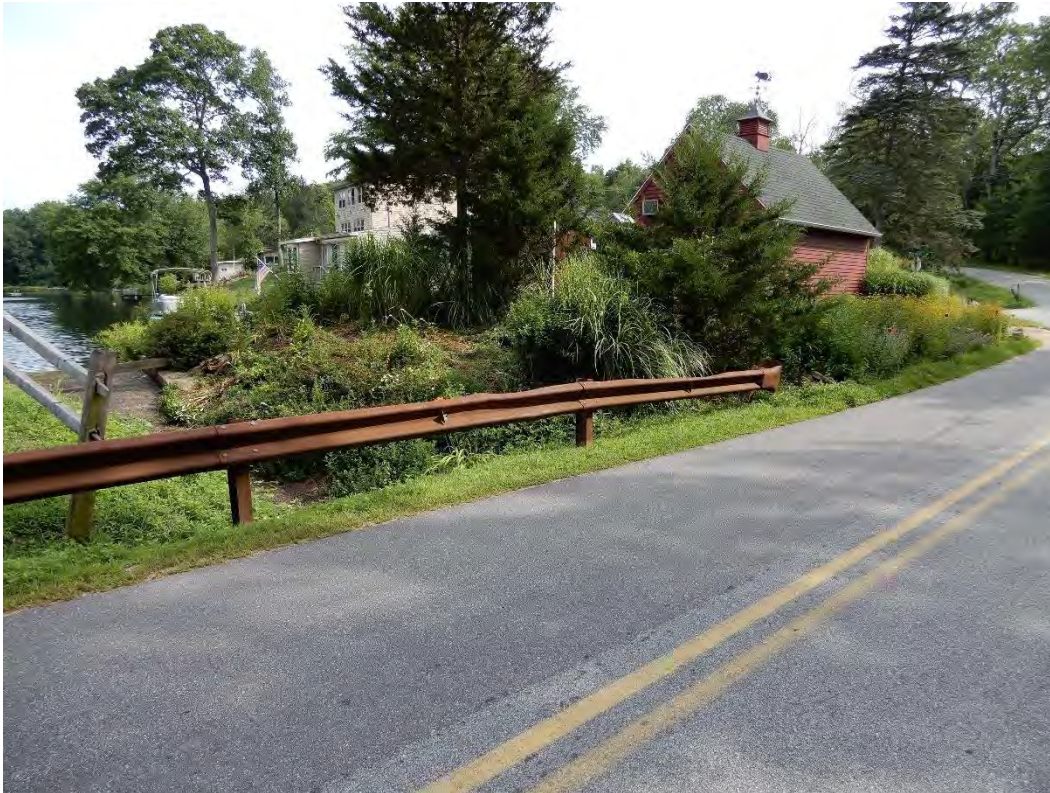
Photo 8b – The left side downstream embankment face (to the left of the left side spillway), prior to the removal of brush and vegetation.

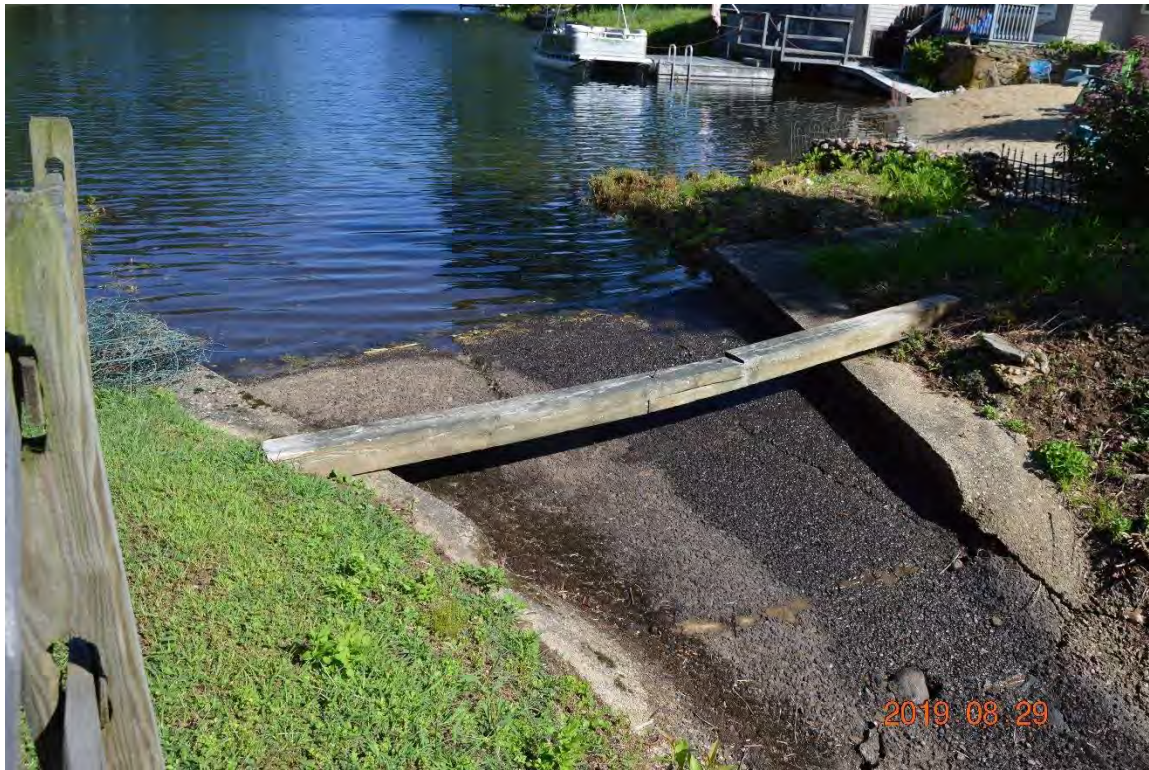
**Cracks:** Several noted, including at the center of the upstream end of the weir, along the right training wall, and along the downstream portion of the discharge chute.

Photo 13a – The left side spillway weir.

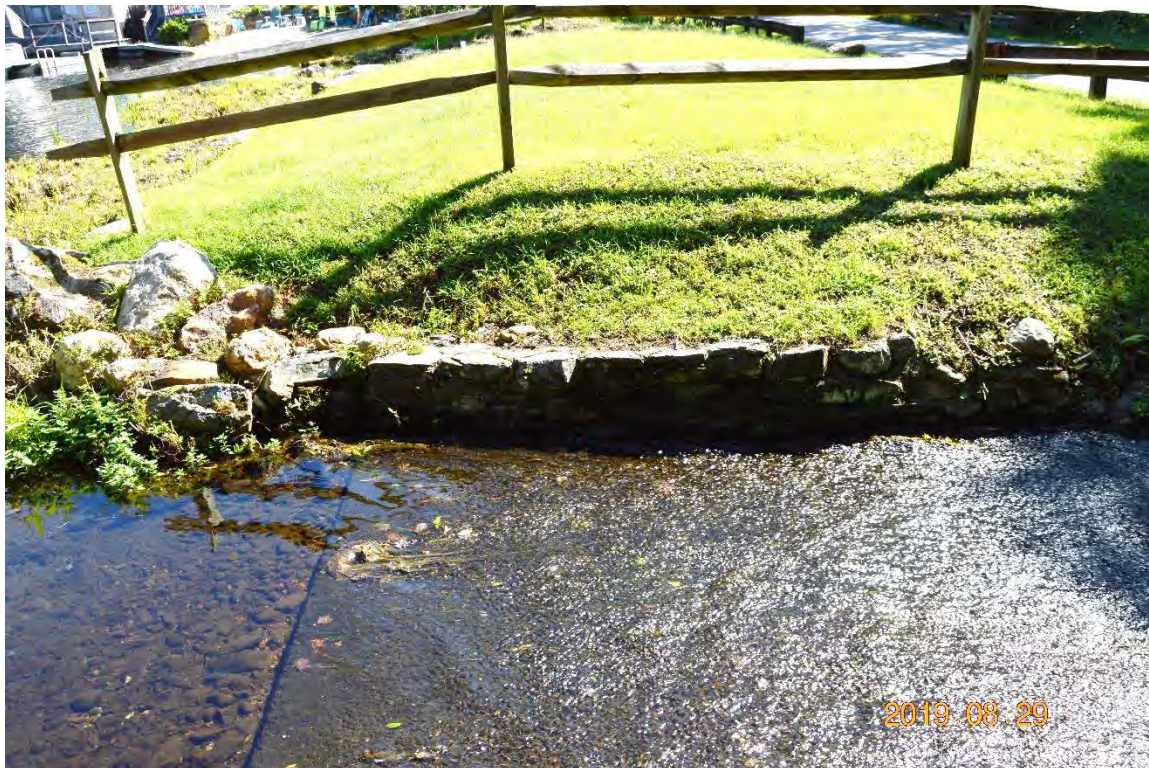
Photo 13b – The right side spillway weir.

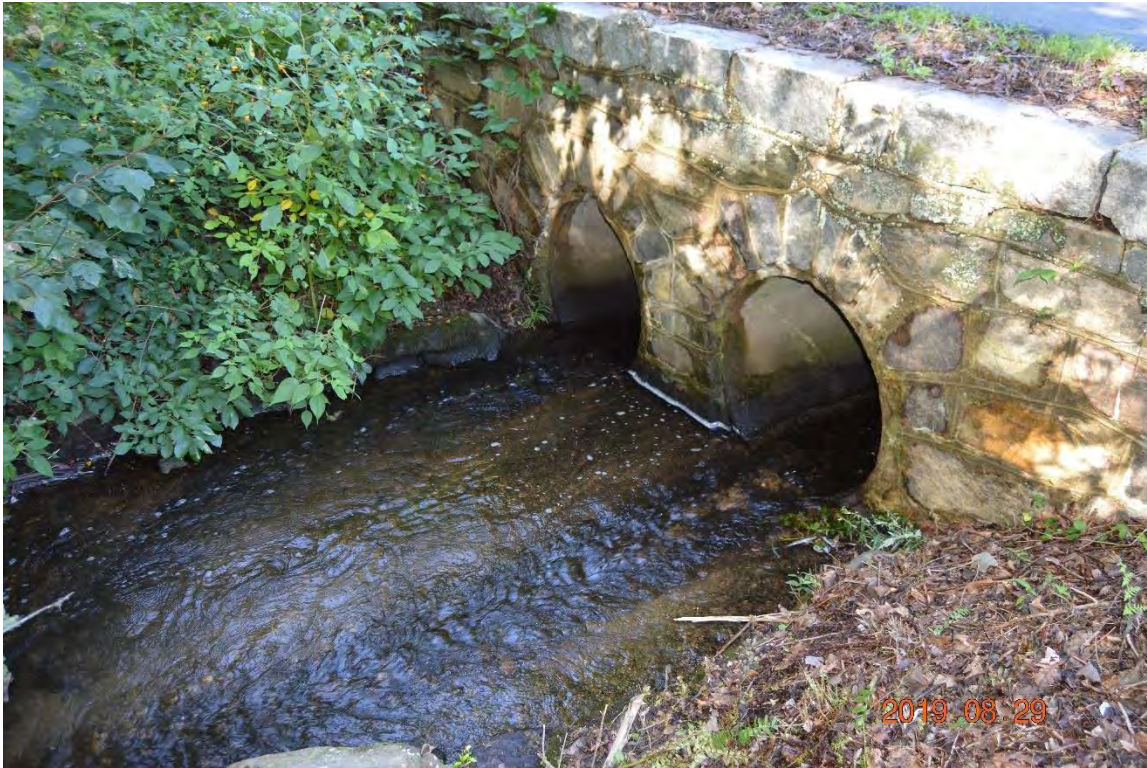
Photo 19c – The downstream end of the right side outlet pipes. The endwall is in good condition.

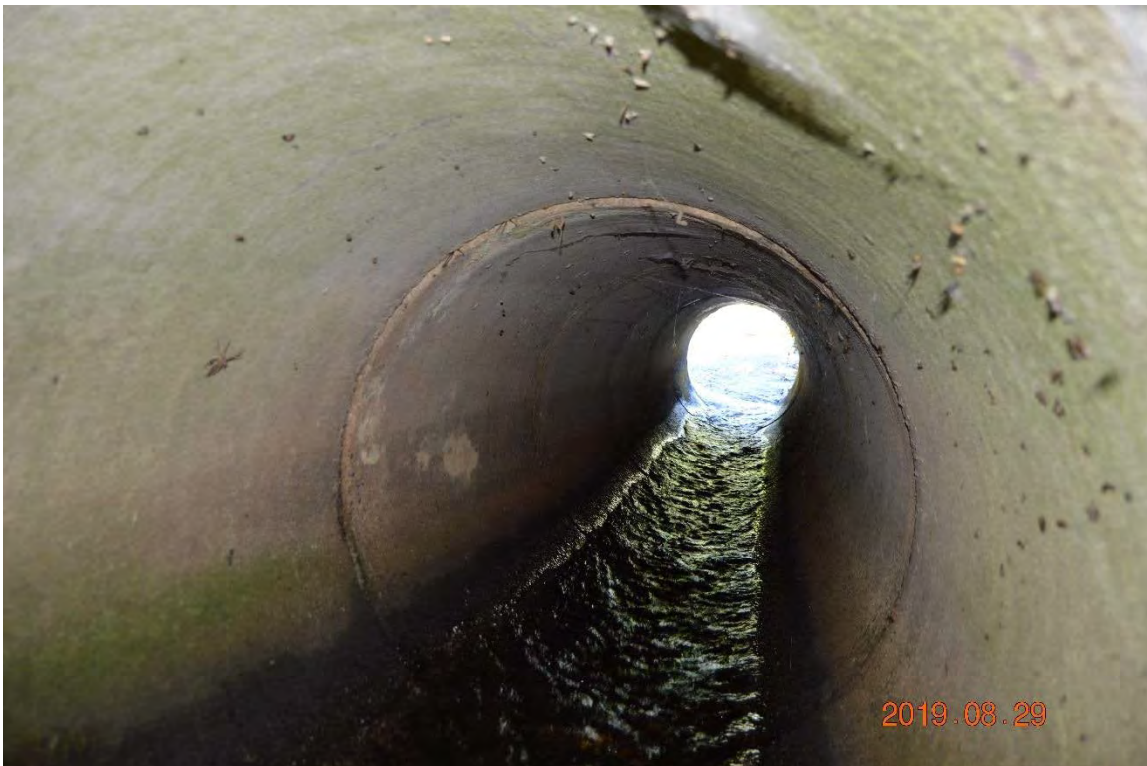
Photo 19d – The interior of the left of the twin right side outlet pipes, in good condition and representative of both pipes.

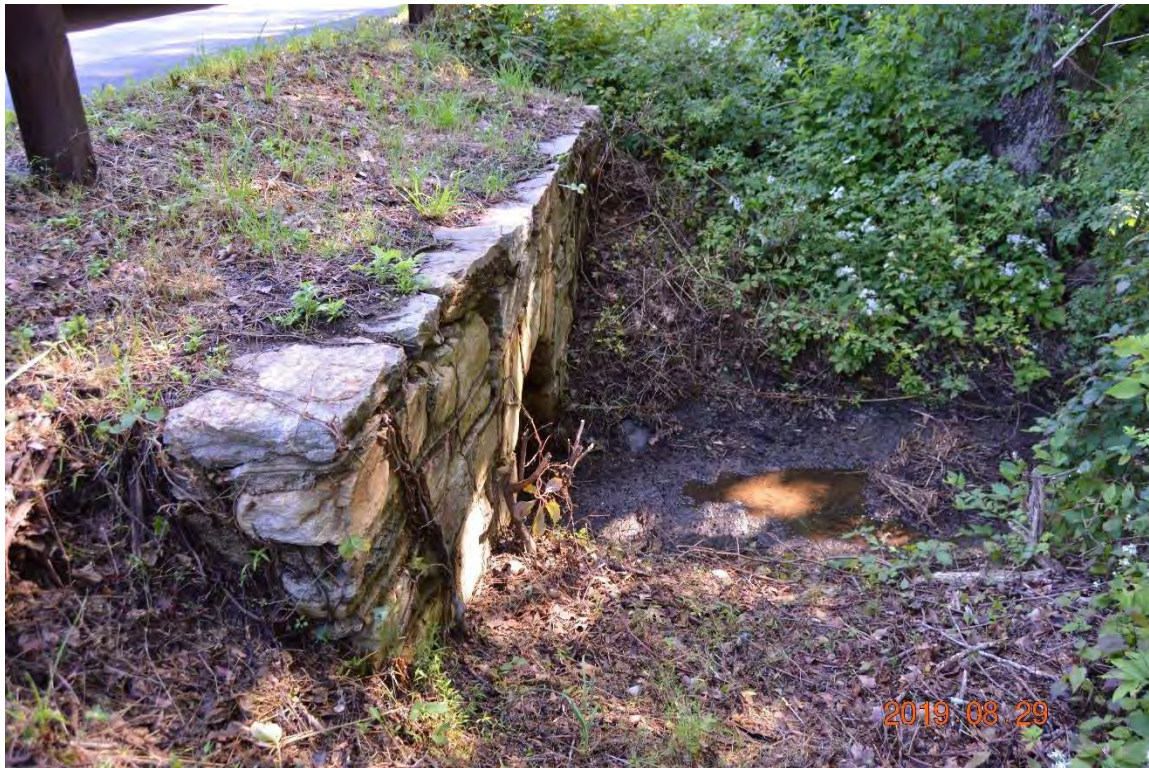
Photo 19e – The downstream end of the left side outlet pipe. This endwall is also in good condition.

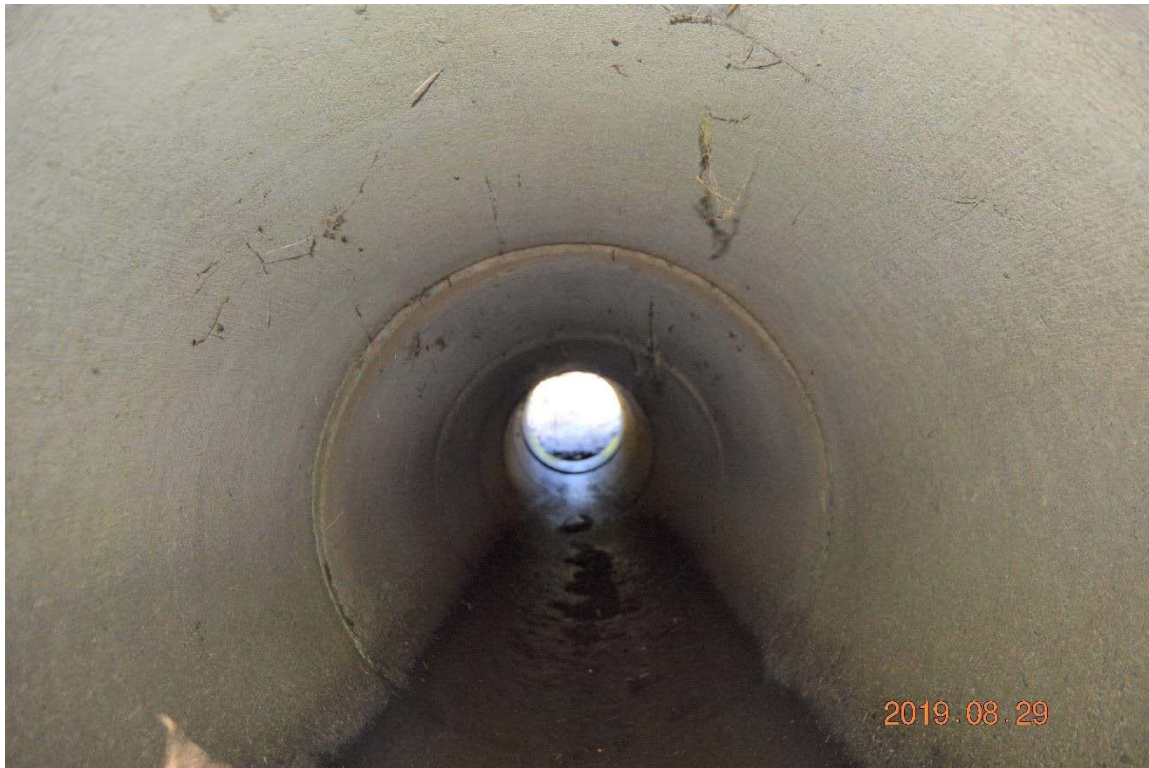
Photo 19g – The interior of the left side outlet pipe, in similarly good condition to the two right side pipes.

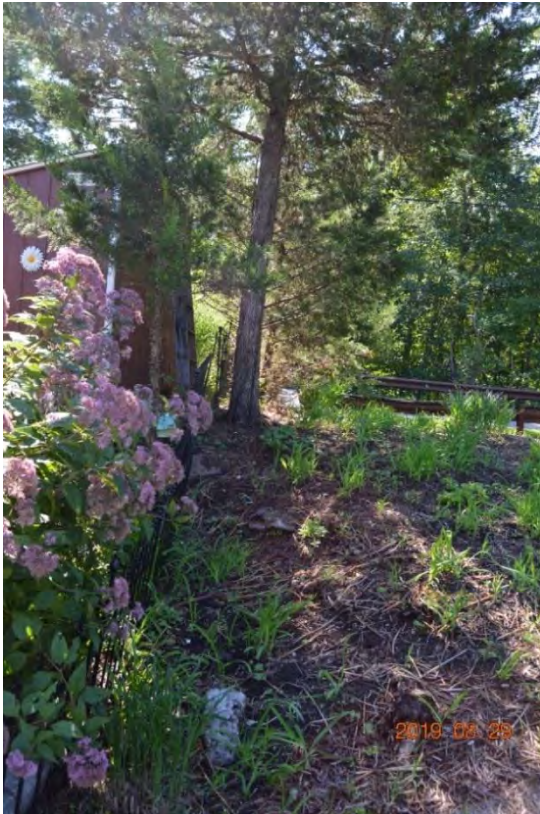
Photo 21a – The upstream side of the left embankment, most of which was cleared of vegetation along the slopes after the first inspection. Dense and woody vegetative growth should continue to be removed, and a sound grass cover established and maintained.

Several small to medium size tree stumps were noted along embankment sections, from clearing as had been requested through previous DEEP inspections and correspondence. While none of these stumps present any current issues or problems, they should be monitored for any changes, particularly for signs of subsidence. Should such changes occur, an engineer should be consulted as to the proper disposition, fill materials and compaction, depending upon location on the embankments.

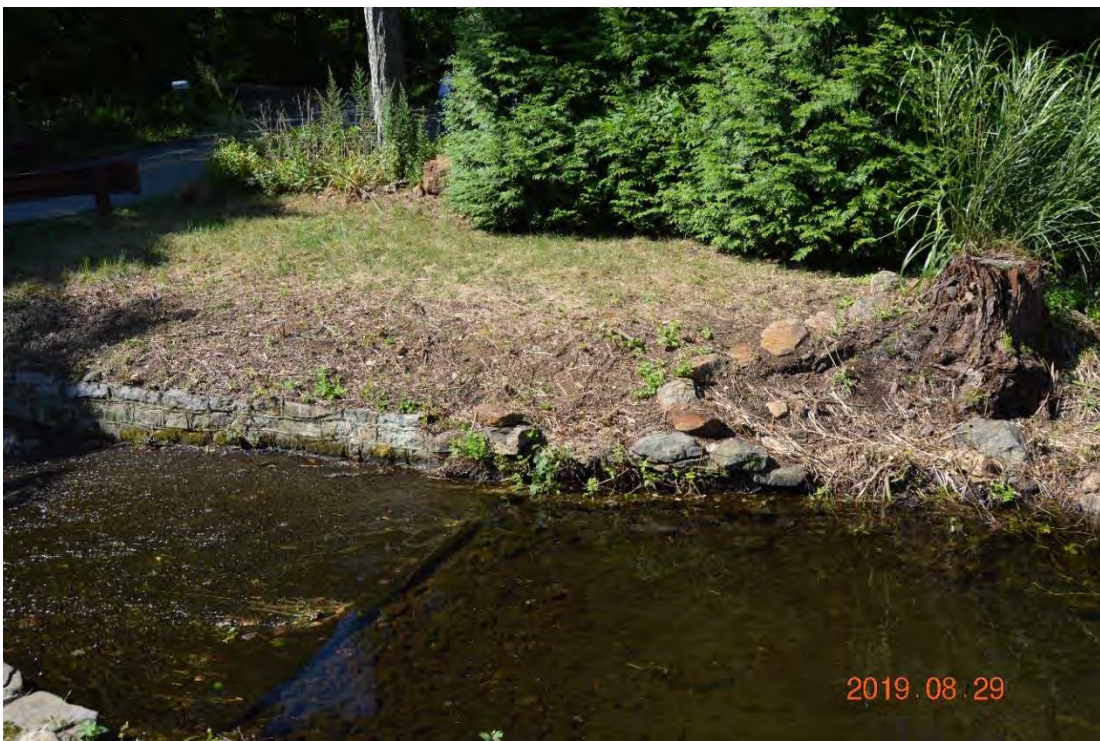
Photo 21b – The embankment along the right side of the right discharge channel. This area was recently cleared of brush and vegetative growth, and should have a grass cover established and maintained. The tree stump (from previous clearing) must be monitored and any depression resulting therefrom filled in as required if subsidence should occur. In the event of reconstruction of the training wall area, the stump and roots should be removed at the same time. The training walls in this area have deficiencies that require improvements and repairs.

**2. Spillways & Training Walls** – Based on the hydrologic and hydraulic analysis, significant flows passing through both spillways will overtop the side training wall and shallow slope areas adjacent to the weir and channel sections. As previously pointed out, the weirs and adjacent slope areas are currently stable, but show signs of previous displacement of training wall masonry in close proximity to the weir sections. And, because this situation could lead to potential erosion of the side slopes and create debris blockage along the channels and culvert entrances, we would recommend that the weirs, the training walls and side channel slopes be reconstructed with concrete wall sections or a combination of walls and concrete filled riprap along the side slopes. Because of the earthen side slopes and their susceptibility to erosion, we would recommend that modifications to the eastern (left side) spillway and discharge channel be undertaken first. This would prevent potential erosion of slopes, displacement of stones currently lining the areas adjacent to the weirs, and buildup of debris from the erosion at the culvert entrances. Temporary remedial measures would include filling in the cracks in the spillway channels and repairing displaced and undermined or eroded stone masonry.

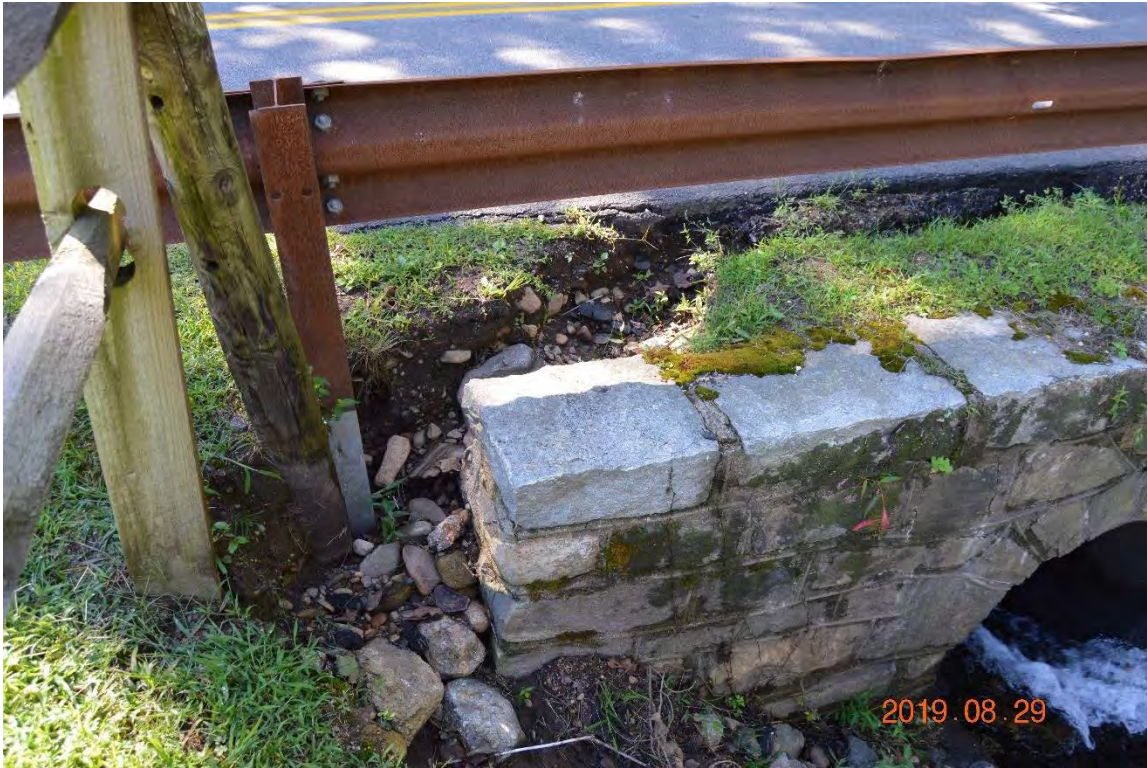
Photo 21c – An area of washed out soil, caused by runoff from Haywardville Road, running around the right side discharge culvert endwall at the time of inspection. This area was subsequently repaired (see below).

**4. Roadside Erosion at the Right Upstream Headwall** – The erosion shown in the photographs at this location was recently (i.e., subsequent to the inspection of the dam) repaired with the placement of asphalt in the eroded flow channel. While this is a temporary fix, it is not considered a long term solution. We would encourage the Town to install a catch basin near the low point area of the erosion problem just west of the headwall and then divert flow through a piping system to the downstream channel. This will avoid flow at the headwall altogether and avoid additional flow on the inlet side of the culvert. Long term repairs can then be combined with the recommended improvements to the discharge channel training walls noted in No. 2, above.

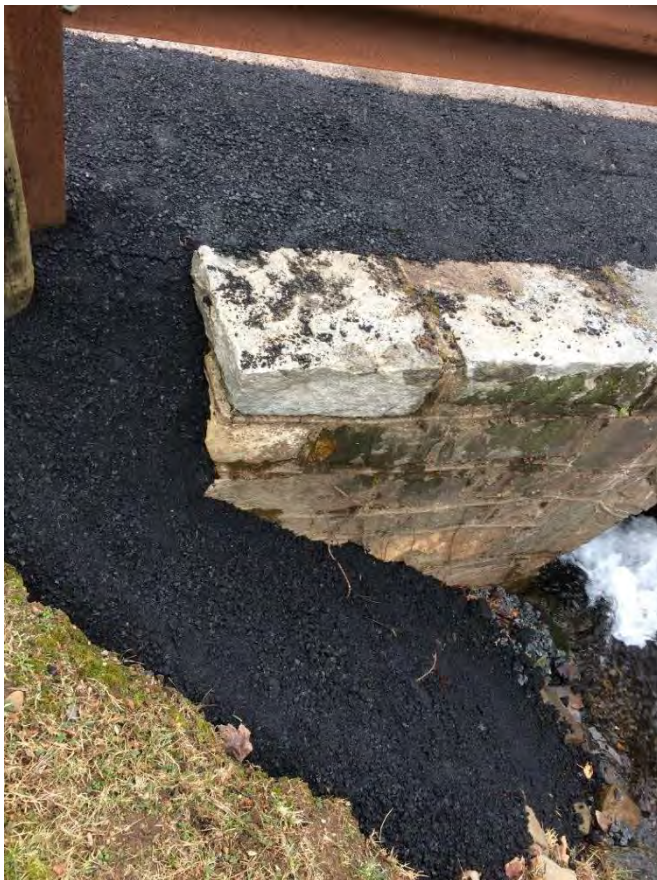
Photo 21d – The same area as the previous photo after placement of surficial asphalt in the eroded area. See the long term recommendations in the preceding sections.

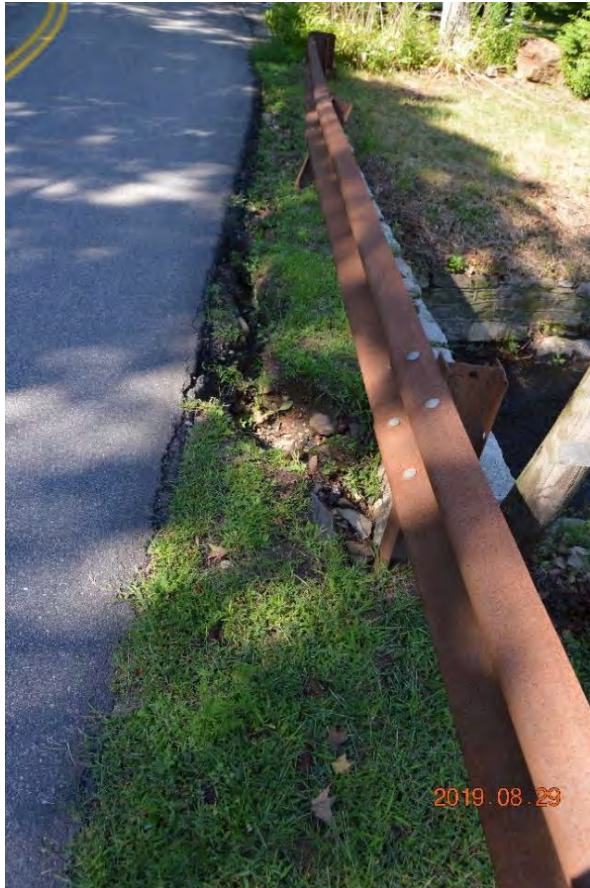
Photo 21e – Looking westward toward the source of the erosion shown in the prior two photos. There is no curb or other implement to direct drainage flowing downhill along the road away from the grassed area at the low point near the endwall.

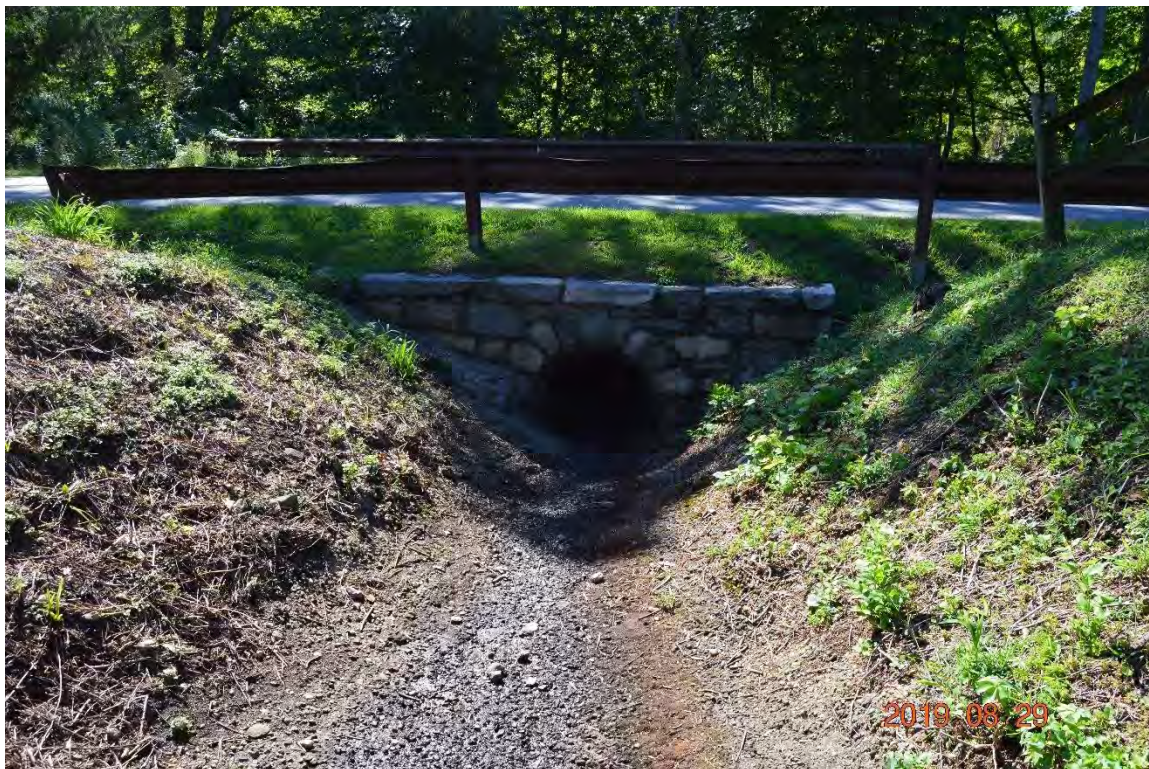
Photo 21f – The lower portion of the left discharge channel. Side slope areas where brush growth was recently cut must be kept cleared with the reestablishment of a grass cover to prevent erosion during high flow situations. (See Section XII for additional long term recommendations.)
