# LAKE HAYWARD WATERSHED MANAGEMENT PLAN

January 2021

*Prepared by the Lake Quality Improvement Committee of Lake Hayward  
With Technical Contributions from SLR International Corporation (formerly Milone & MacBroom, Inc.)*

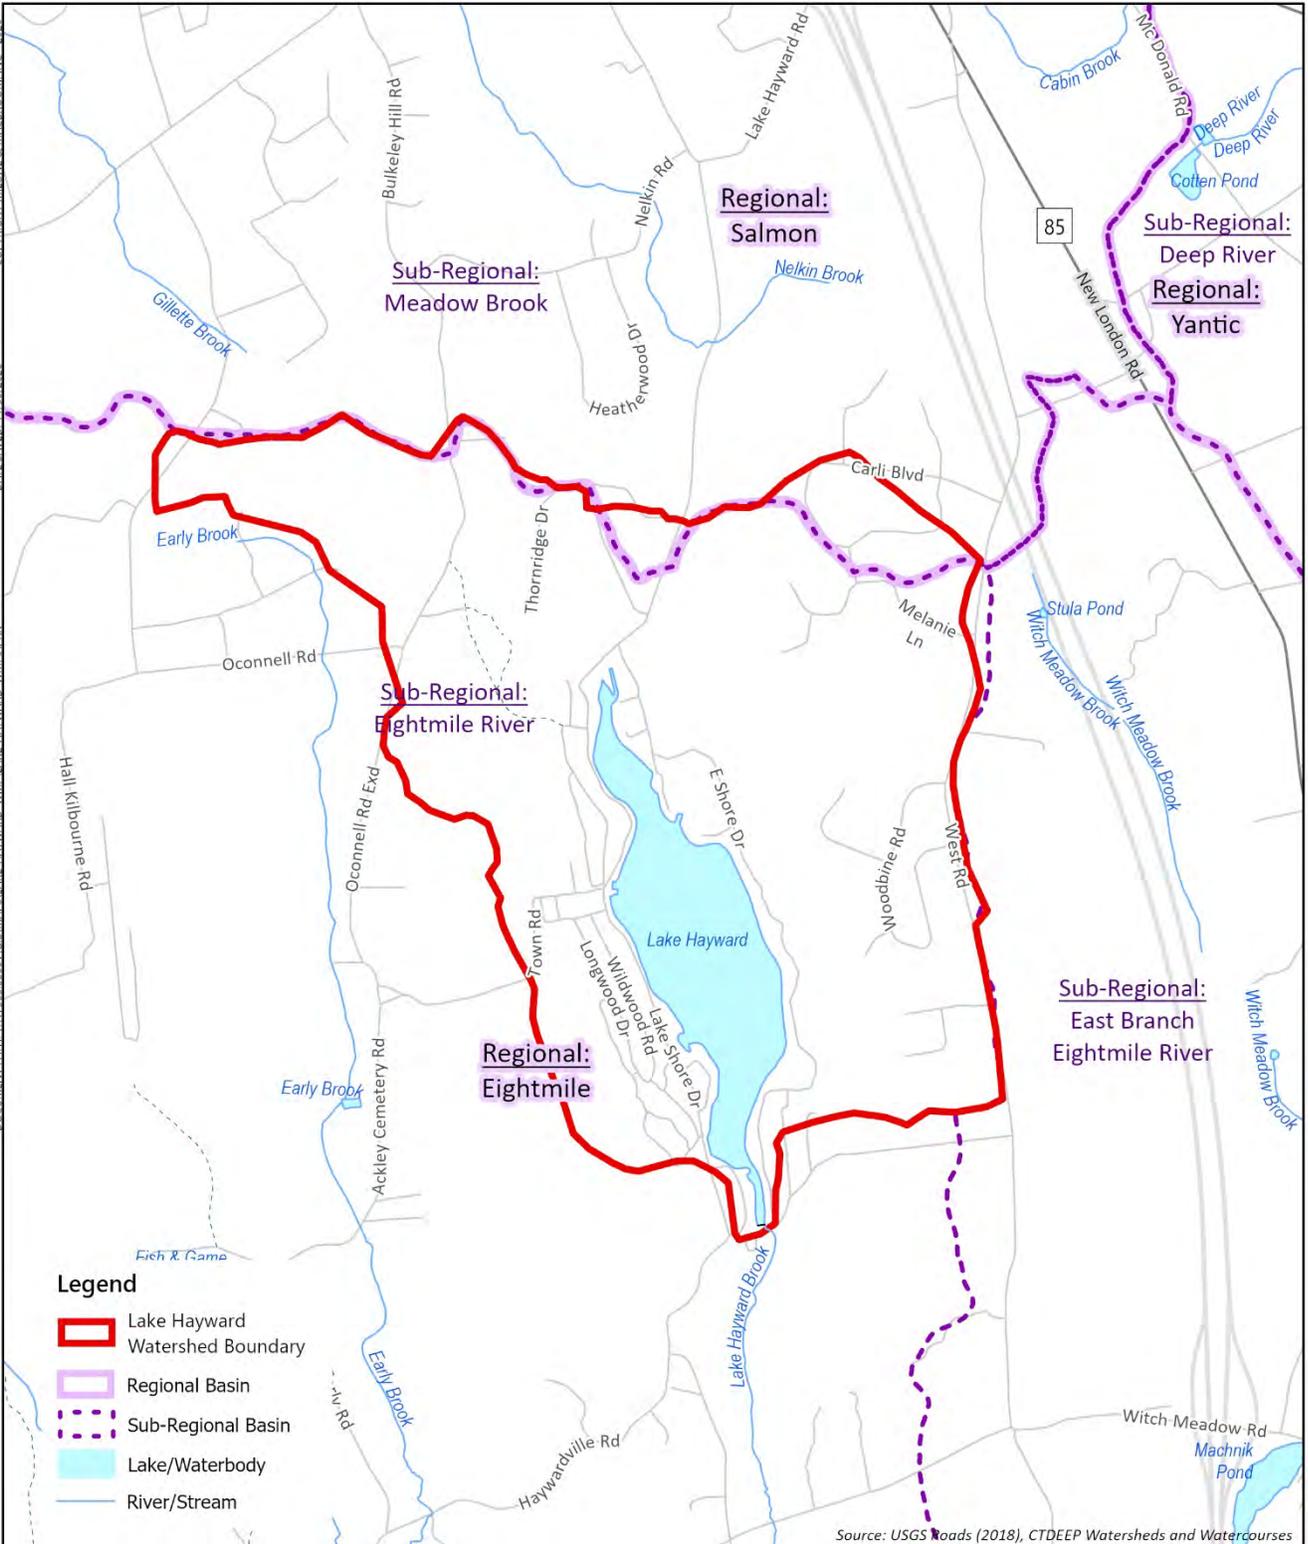
Finally, two distinct areas of "swamp" (shown in pink in Figure 2-4) are notable adjacent to Lake Hayward. These are located immediately adjacent to and east of the lake between East Shore Drive and Lake Hayward, and immediately to the north of the northern point of the lake. These areas are highly visible natural wetlands, with a variety of aquatic and plant species. These areas are discussed in greater detail in Section 6.0.

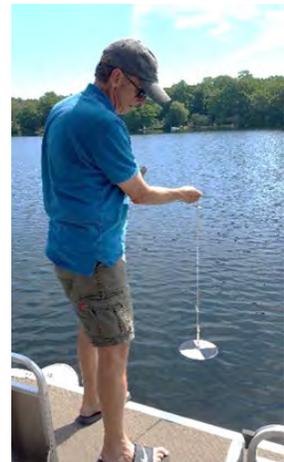
FIGURE 3-1

LQIC has collected a large amount of historical Secchi data, though much of it is one or two readings taken in a particular year. Figure 3-1 shows historical Secchi depths over the last six years. There is no apparent overall trend in increasing or decreasing transparency. Less transparency may be associated with algae blooms.

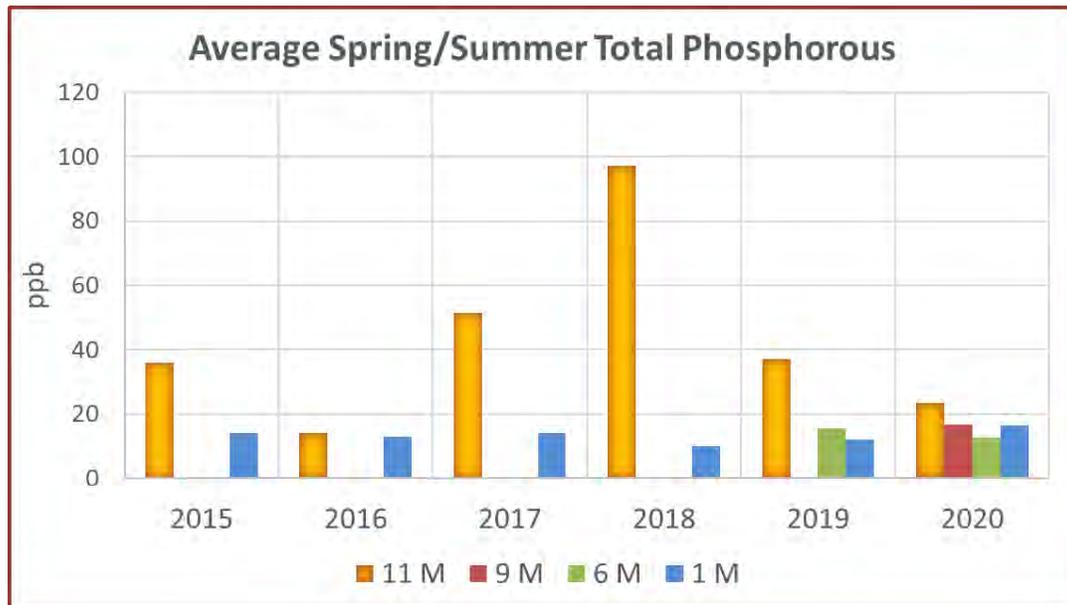
FIGURE 3-2

Phosphorus can be present as dissolved or particulate and organic or inorganic-bound forms. Studies in this region have focused on total phosphorus (TP) rather than individual fractions. This is in part to simplify sampling and analysis but also because phosphorus has been shown to transition between phases. In 2015, LQIC began monitoring surface and bottom water samples for TP collecting samples with a van Dorn sampler and delivering to an analytical lab for analysis. This was expanded in 2019 to increase the frequency of sampling and to add intermediate depth samples. Figure 3-2 shows sample results for these years. The surface phosphorus has not changed significantly, but the bottom samples are highly variable.

The higher phosphorus concentration from water sampled at 11 meters is due to accumulated phosphorus in anoxic water. In the summer, the development of density differences due to temperature stratification keeps the bottom water separate from the surface waters and is no longer in contact with the air. Decomposition in the sediment consumes oxygen that can eventually create anoxic waters in the hypolimnion. Since phosphorus is soluble in anoxic water, any phosphorus that comes out of the sediments or is precipitated from the water column above will generally remain in solution. Together, these two processes account for the higher accumulation of phosphorus in the bottom layers. Herbicide treatment also may increase oxygen

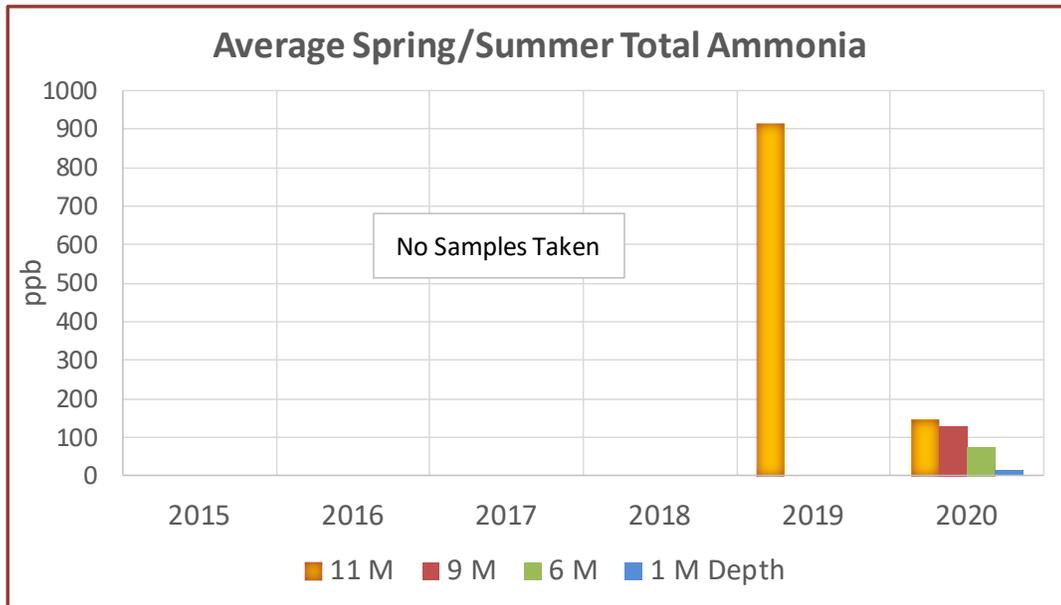
FIGURE 3-4

Ammonia is the part of TN that is preferred by microcystis cyanobacteria, which dominated the algae in the lake in 2019. Figure 3-4 shows the average Spring/Summer NH<sub>3</sub> sample results for 2019 and 2020. Much of the TN is in the form of NH<sub>3</sub>. Nitrogen and ammonia were not sampled in recent years prior to 2019.

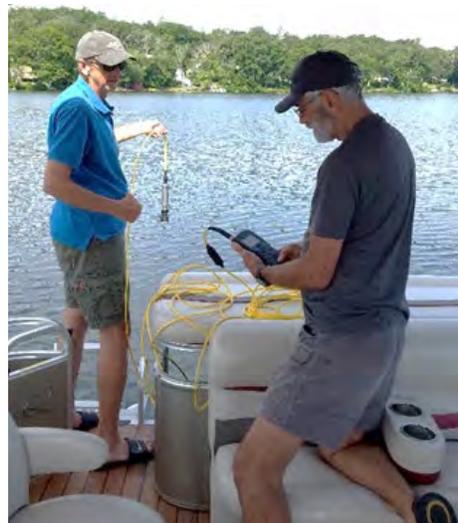
**FIGURE 3-7**

Figure 3-7 compares the height of the August anoxic boundary in 2019 and 2020 with prior sampling done in 2000 and 2001. The height of the anoxic boundary is clearly higher now than it was in 2000/2001. Anoxic water promotes a number of chemical reactions in the bottom sediments that release nutrients including nitrogen, phosphorous and ammonia from the lake bottom. The higher the anoxic boundary, the more severe anoxic conditions can be expected lake-wide.

The surface waters of the lake are saturated with dissolved oxygen due to mixing with air. The bottom waters are deficient in dissolved oxygen due to bacterial decomposition of dead leaves and other organic matter. When the dissolved oxygen is essentially zero near the bottom, the water is said to be Anoxic. The depth where water begins to be anoxic is called the anoxic boundary. The height (inverse of depth) of the anoxic boundary varies over the year, but typically peaks in August.

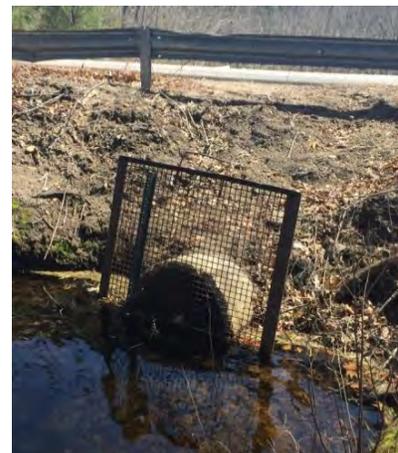
The culvert beneath Lake Shore Drive is a ±36-inch concrete pipe that conveys water beneath the road and hydraulically connects the main lake to the back water. The upstream end of the culvert (shown in the top photograph to the right) has

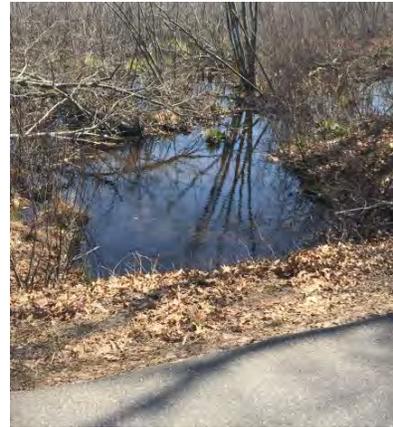
been fitted with a steel grid trash rack. The downstream end of the culvert (shown in the bottom photograph to the right) discharges into a backwater scrub area of the lake. The pipe is oriented such that it is directed towards the bank. Some undercutting of the bank is evident but is not severe. The pipe is supported by a rock retaining wall that is in fair to marginal condition. Water was running clear on the day of inspection (4-17-16), with no evidence of sediment contamination. This is expected, as the area north (upstream) of Lake Shore Drive acts as a sediment forebay to the lake.

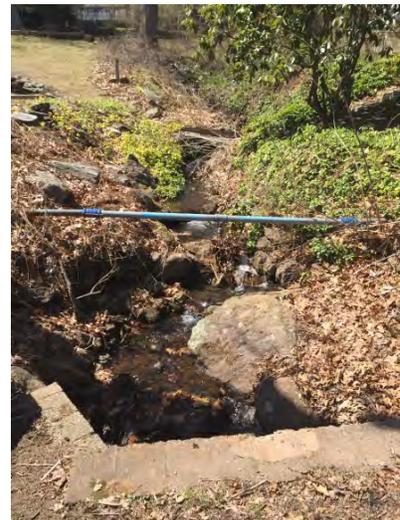
A steep flow channel only several feet wide conveys water during the wet months and following rainstorms down the hill and to a 24-inch corrugated metal pipe that flows beneath Lake Shore Drive. The pipe has a mortared block headwall on both the upstream and downstream ends. A metal pipe spans the flow channel upstream of the culvert beneath Lake Shore Drive (shown in the left-hand photograph). Its purpose is unknown.

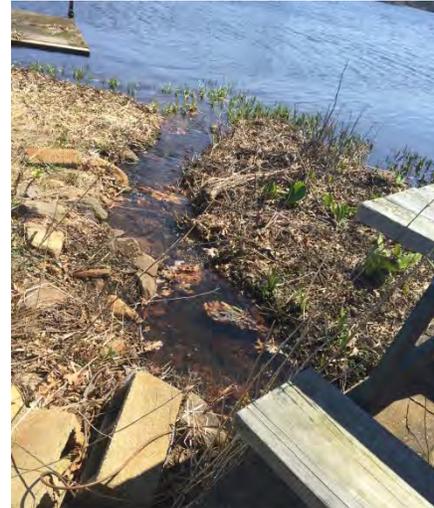
The downstream end of the outfall at W-1 flows beneath a lawn area and then discharges into the lake. A sizable vegetated delta has formed at this outfall, likely having developed over decades following the initial development around the lake and the subsequent formation of the incised drainage channel from the hill. Water that discharges from this outfall flows through a small channel that runs through the delta before discharging into the lake. The substrate is a mix of sand and small cobble and the outfall pipe is free of accumulated sediment.

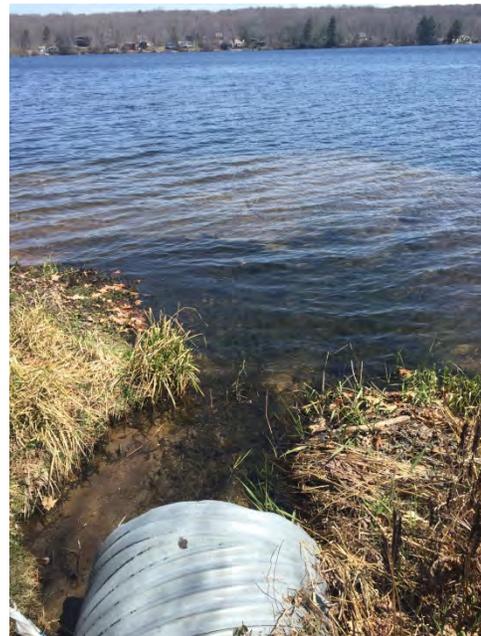
Stormwater along Hilltop Road and Lake Shore Drive is collected and conveyed through catch basins, piping, and overland flow directed to a 34-inch corrugated metal pipe that discharges to the lake.

Major sediment accumulation has occurred here, with a large underwater delta visible a significant distance into the lake (as seen in the photograph to the right). It appears that the flow

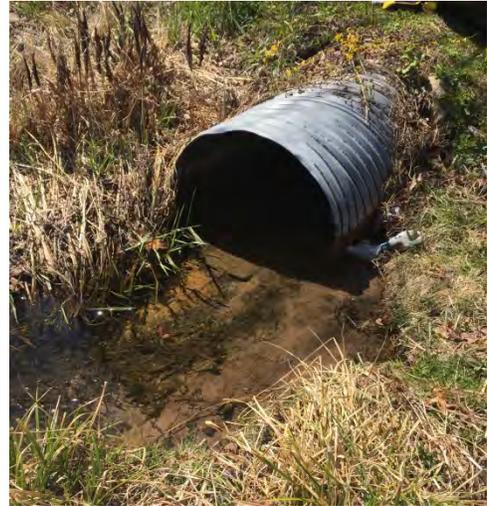
path at the outfall may have been manually dug out at one time to maintain an open flow path. The pipe is partially clogged with sediment, with approximately three-quarters capacity remaining. This outfall was cited as one of the top 6 priority outfalls identified in the 2012 study Stormwater Management Study as was a second outfall immediately adjacent to it, which is no longer visible. Upon closer inspection, this pipe has been partially squashed, is more than half full of sediment, mostly underwater, and no longer functioning.

Given the high degree of sediment accumulation, the densely developed area draining to this outfall, and its proximity to a public bathing beach, this sub-watershed is considered to have high priority relative to stormwater impacts. Frequent catch basin clean-out, public education and implementation of volunteer stormwater management, and construction of a bio-detention or bio-infiltration basin are recommended.

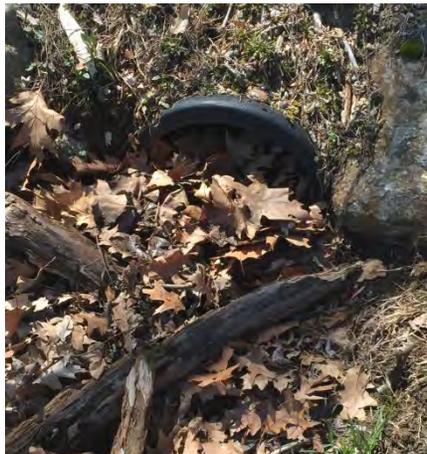
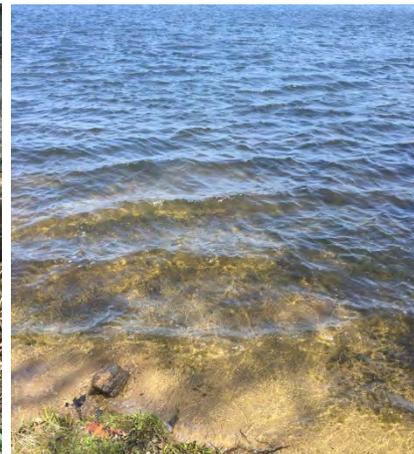
A 12-inch corrugated plastic pipe outfall pipe is visible but completely clogged with sediment, leaves, and debris (see left-hand photograph to the right). This outlet is not functioning at all. The upstream catch basin on Lake Shore Drive has been observed to have standing water and may

be vulnerable to flooding during high intensity or prolonged storm events. The shoreline in the area of the outfall shows evidence of historic sediment accumulation and formation of a delta that extends well into the lake.

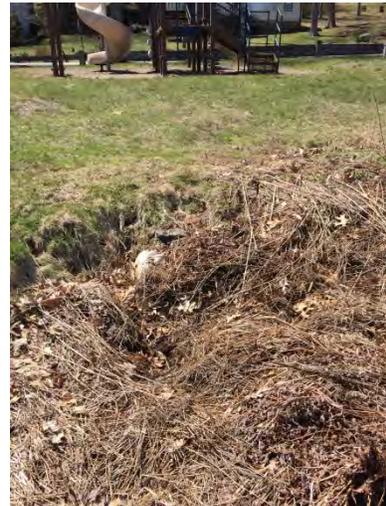
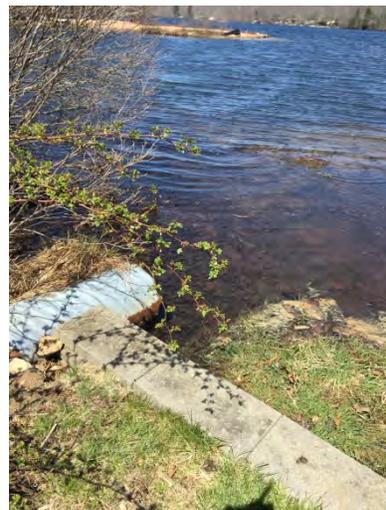
A 20-inch corrugated metal pipe discharges into the cove just north of a paved patio area that extends nearly to the water's edge. The outfall carries drainage from catch basins on both sides of Lake Shore Drive. The pipe is visibly rusted on the bottom half and appears to be completely rusted through along portions of its length, evidenced by water bubbling from the ground. While the cove was dredged in 2014, the excavation did not extend to this area of the cove and historic sediment deposits are visible beneath the water near this outlet. The cove clearly acts as a form of settling basin for sub-basins W-4 and W-5.

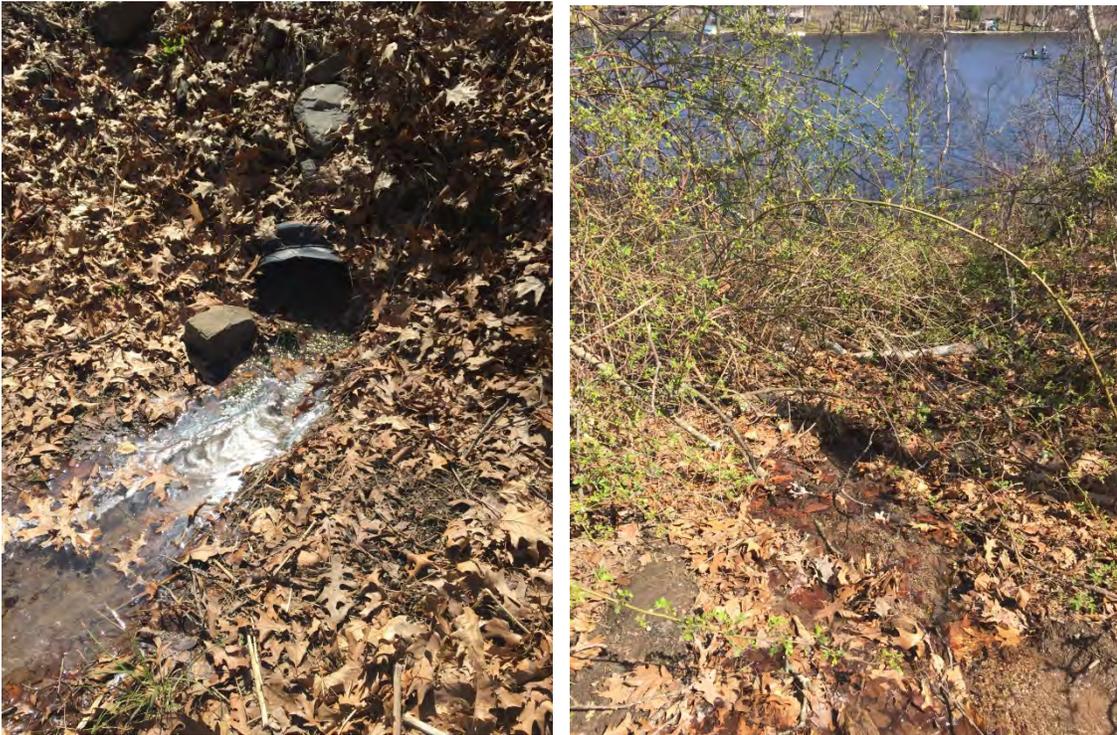
Sub-basin W-6 drains approximately 23 acres of steep and very steep terrain, including portions of Cragmere Road, Longwood Road, Wildwood Road, and Lake Shore Drive. A number of catch basins collect water from the steep hillside and route it beneath Lake Shore Drive north of Third Beach.

The culvert discharges onto bare ground on the waterward side of Lake Shore Drive and flows overland down a hill before discharging into the lake. This outfall was cited as one of the top 6 priority outfalls within the Town of East Haddam as identified in the 2012 study entitled *“Stormwater Management Priorities: Roadmap for Rural Towns Study”* funded by the Long Island Sound Futures Fund and coordinated by the Eightmile River Wild & Scenic Coordinating Committee. Given the steepness of the contributing area to this sub-basin and the historic poor water quality, it is considered to be a high priority sub-basin.

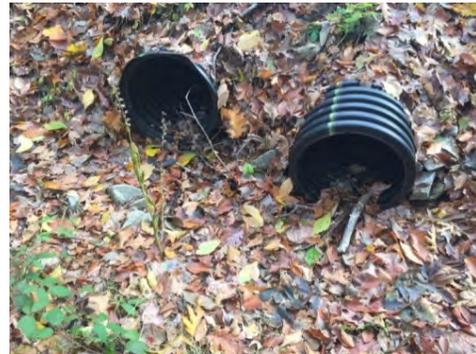
A single stormwater pipe crosses East Shore Drive within sub-basin E-1, consisting of twin 18-inch corrugated plastic pipes (CPP). Often, no flow can be observed in the pipes, even after prolonged periods of rain. The ground upstream and downstream of the crossing is well vegetated and there was no evidence of erosion or sedimentation. Downstream of the twin culverts, overland flow sheds towards the lake.

Aerial photographs show evidence of two seasonal streams within basin E-1, which combine upstream in the watershed before reaching East Shore Drive. Under most conditions, however, there is no visible flow path from the road to the lake.

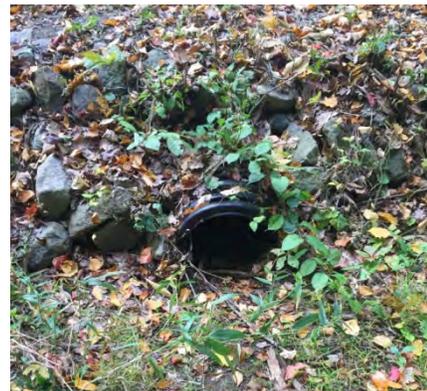
Sub-basin E-2 drains approximately 46 acres of largely undeveloped wooded land. The exception is a small residential area at the end of the Hunters Court cul-de-sac in Colchester. The crossing within sub-basin E2 consists of a single 12-inch CPP. A hill drains to the culvert on the east side of the road with what appeared to be placed rocks to dissipate flow, though visibility was hindered by the heavy fall leaf cover. No erosion was evident on the upstream or downstream side of the crossing and no active flow was occurring.

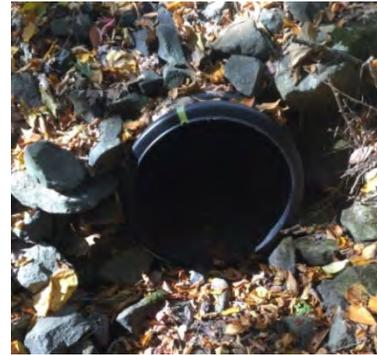
Sub-basin E-3 drains approximately 189 acres of land, including the residential areas along Melanie Road and West Road within the Town of Colchester along the outskirts of the watershed. A stormwater pipe crossing beneath East Shore Drive is a single 24-inch CPP. Flow has been observed at this location running fast and clear, with a clearly defined channel both upstream and downstream of the culvert. There is no evidence of erosion. Water ponds upstream of the culvert and has been observed shooting out in a jet on the downstream side. Flow dissipates somewhat by rocks that have been placed in the channel on the downstream side of East Shore Drive.

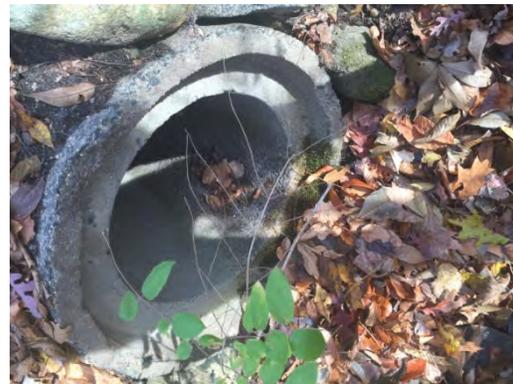
The crossing at sub-basin E4 is a single 18-inch concrete pipe. There was no evidence of flow on numerous inspections; however, an adjacent neighbor indicated that in more typical years (i.e. non-drought), the culvert carries water much of the year. On the upstream side, a depression has formed, likely due to high velocity and ponded water under wetter conditions. There was no evidence of erosion or sedimentation in this area. The slope from the road to the lake was steeper in comparison to other crossings. It is unclear if the flow from this culvert joins the flow from E3.

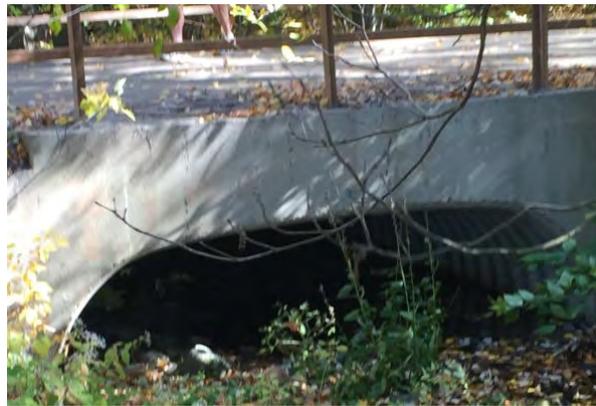
The size of this sub-watershed in combination with the amount of development and impervious surfaces is evidenced by the flow in the lower part of the sub-watershed. The crossing at sub-basin E5 is a squashed corrugated metal arch pipe culvert beneath East Shore Drive. The channel in both the upstream and downstream directions is extremely well defined and it is clear that this sub-watershed has active flow through much of the year.

Water flows downstream from the crossing at East Shore Drive between two cottages and then discharges directly to the lake. A large delta has formed at the outlet, submerged during higher lake levels but clearly visible. Given the size and density of development in this sub-basin, it represents a significant potential source of flow and sediment to the lake. Additional assessment of watershed practices and potential for post-development stormwater management are recommended. This sub-basin is considered to have moderate to high priority relative to stormwater impacts.

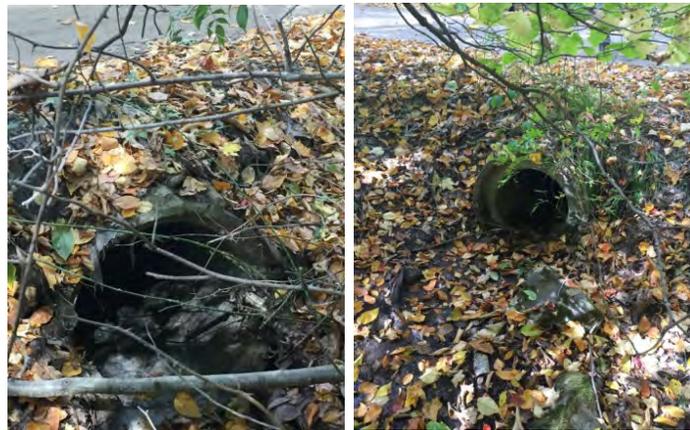
Sub-basin E-6 drains an area of 104 acres, including a portion of West Road and all of Brookside Drive and Meadow Lane, all residentially developed areas within the Town of Colchester. Two crossings beneath East Shore Drive occur within this sub-basin within 50 feet of one another. The northerly pipe, a 24-inch concrete pipe, has been observed passing less flow than the southerly pipe, a 30-inch concrete pipe. The southerly pipe crosses the East Shore Drive and bends northerly before joining flow from the northern crossing.

Water typically runs clear across a sandy bottom flow channel, with some sand build-up evident on the downstream side of the 30-inch (southerly) culvert.

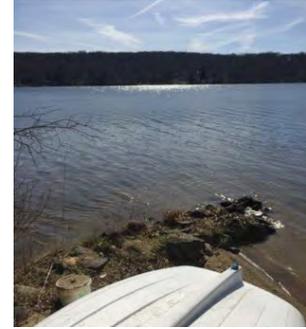
Water that discharges from the two culverts beneath East Shore Drive flows overland in a small stream to its outlet on the east shore of the lake. The discharge has formed a visible delta out into the water, as can be seen in the photograph to the right.

This watershed has a moderate potential to add sediment to the lake, as evidenced by the existing delta.

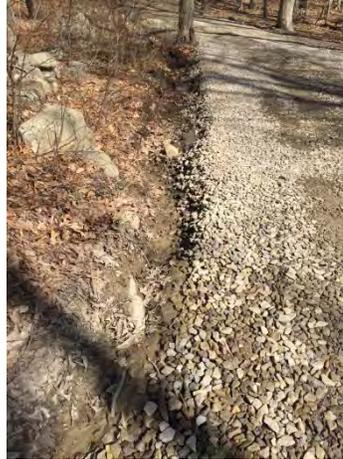
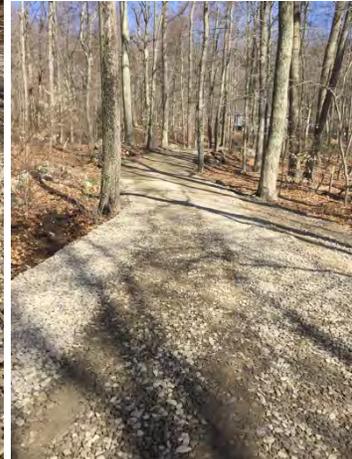
nowhere to go but up, over, and across the road towards the lake. This condition has existed for a number of years, causing the road to wash out during particularly wet conditions and form a sheet of ice during wet, cold conditions in the winter.

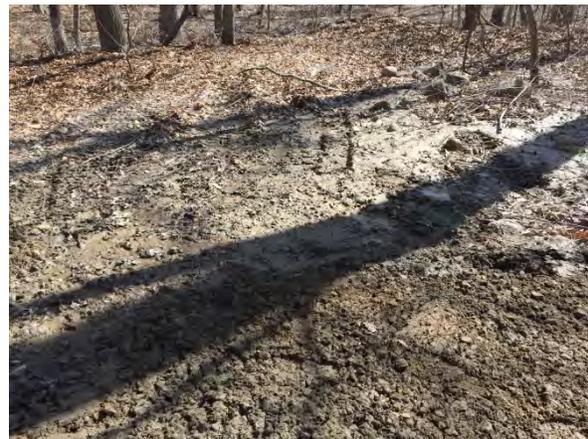
Until the spring of 2016, a large area on the downslope (lake) side of East Shore Drive had been covered with gravel and, while not ideal, afforded some energy dissipation for the sheeting flow across the unpaved roadway. However, when the road was regraded in 2016, as it is every spring, the gravel was destroyed, and erodible soil was left in its place.

A cross culvert and energy dissipator is recommended within this sub-basin to provide a less destructive and a more erosion resistant method of draining water from the east side of East Shore Drive to the west. On May 11, 2016, representatives of the LQIC met with representatives of the Town of East Haddam to discuss potential solutions to this ongoing source of sediment to the lake and a winter hazard when the road becomes covered in a sheet of ice. The Town concurred with the LQIC recommendations and stated their intention to pursue an easement with the landowner on the lake side of East Shore Drive to enable construction of the remedial measures by town forces. Below is a schematic drawing of the solution.

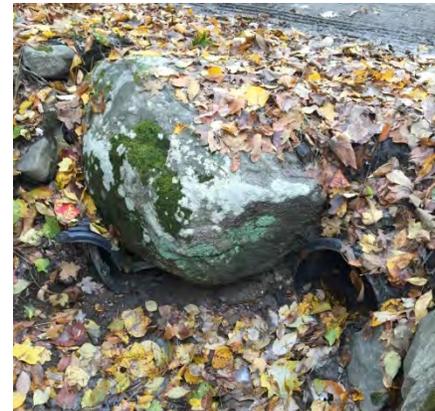
Numerous culvert crossings occur within sub-basin E-7. The most northerly crossing is a 12-inch CPP that was not carrying any flow on the day of inspection. A catch basin to the south accepts flow from a turquoise 4-inch or 6-inch pipe pitching down from the hill, but the outlet of the catch basin, which appears to discharge to the north, appears crushed and non-functioning where it would otherwise discharge at the 12-inch CPP culvert crossing. On the downstream side of the crossing, water flows overland through a forested area towards the lake. Riprap is evident on the downstream side of the crossing, suggesting that at times, flow and velocity may be significant here.

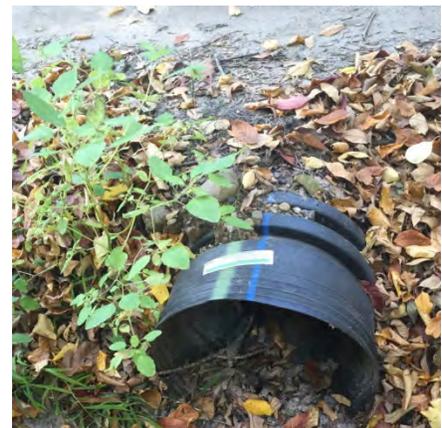
Further to the south, several additional culverts cross beneath East Shore Drive. These appear to be localized attempts at shedding water across the road from individual homes. They are largely clogged with sediment and debris and not functioning well.

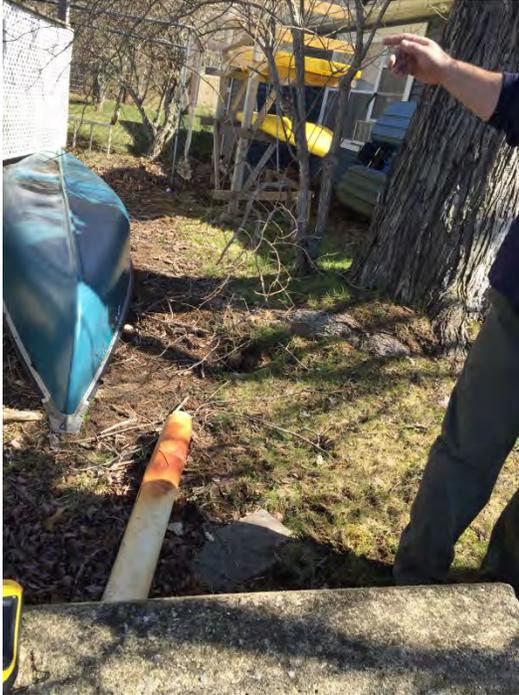
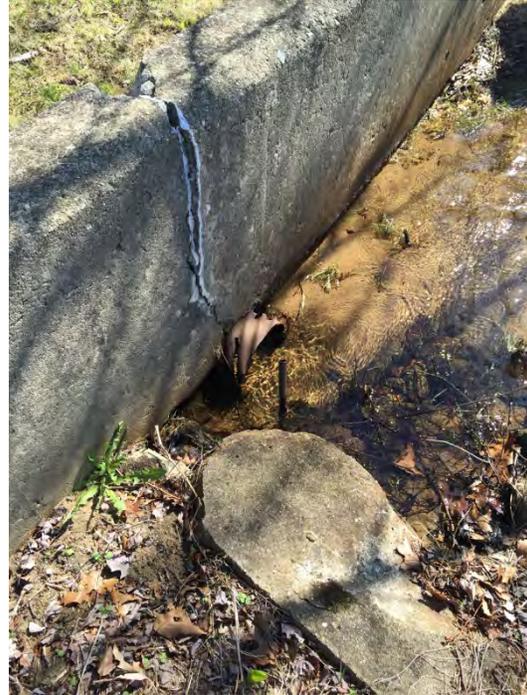
The final crossing within sub-basin E7 occurs near East Shore Drive and has been observed actively flowing, following significant periods of rain. The flow in this area from the road to the lake occurs in a circuitous path, crossing beneath several low-lying plank footbridges, along a stacked rock wall and through a wooded area. Eventually, this stream joins several other localized flow paths and eventually discharges into the lake through a galvanized pipe that flows adjacent to several cottages.

The pipe discharges through a cracked concrete wall into the lake. The pipe is half submerged into the lake sediment and appears to be only marginally operational.

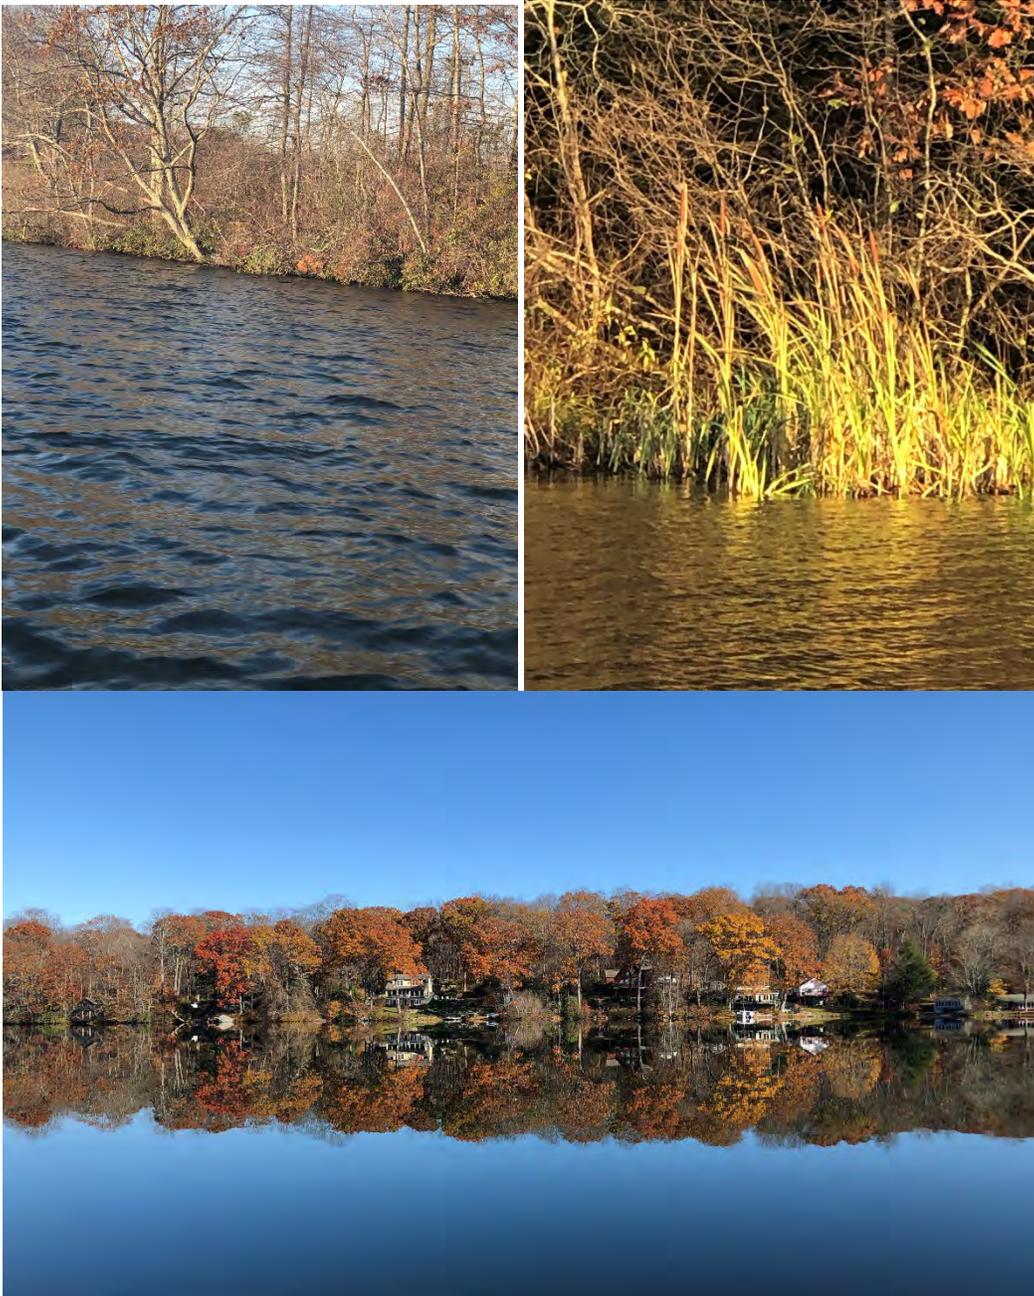
*Photos of the eastern shoreline of Lake Hayward*

Lake Hayward is surrounded by medium density residential uses, with greater density on the western side of the lake. Much of the lake is immediately bordered by developed residential lots, with varying types of vegetation at the land/water interface ranging from maintained lawns to constructed rain gardens. The photos below capture a range of existing conditions on the east side of the lake.

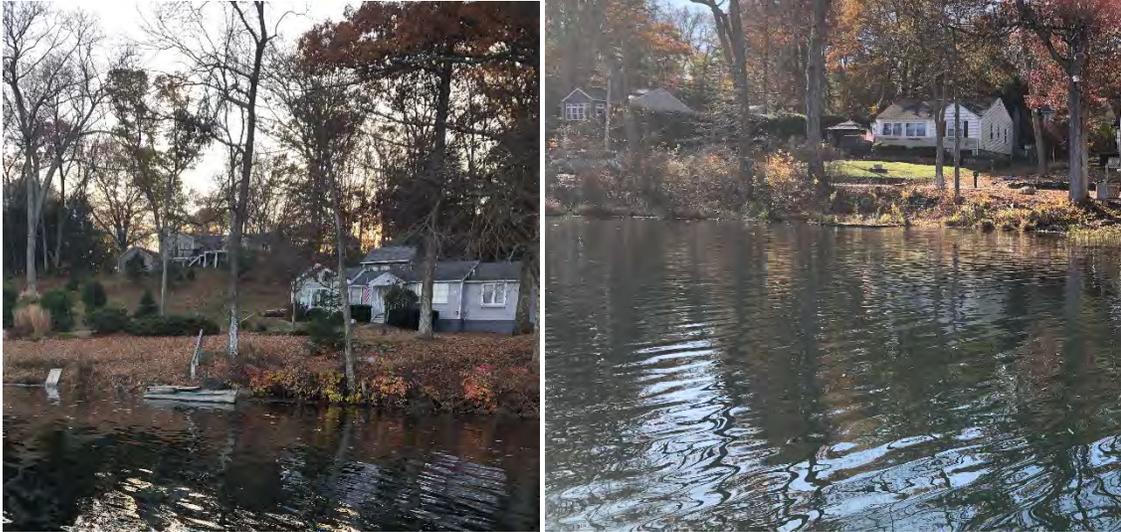
*Photos of the western shoreline of Lake Hayward*

The western shoreline of Lake Hayward is characterized by more densely developed residential land uses, with Lake Shore Drive traversing between the lake and the homes in the northern half of the lake. The western shoreline tends to be less vegetated at the water/land interface. The photos below capture a range of existing conditions on the east side of the lake.

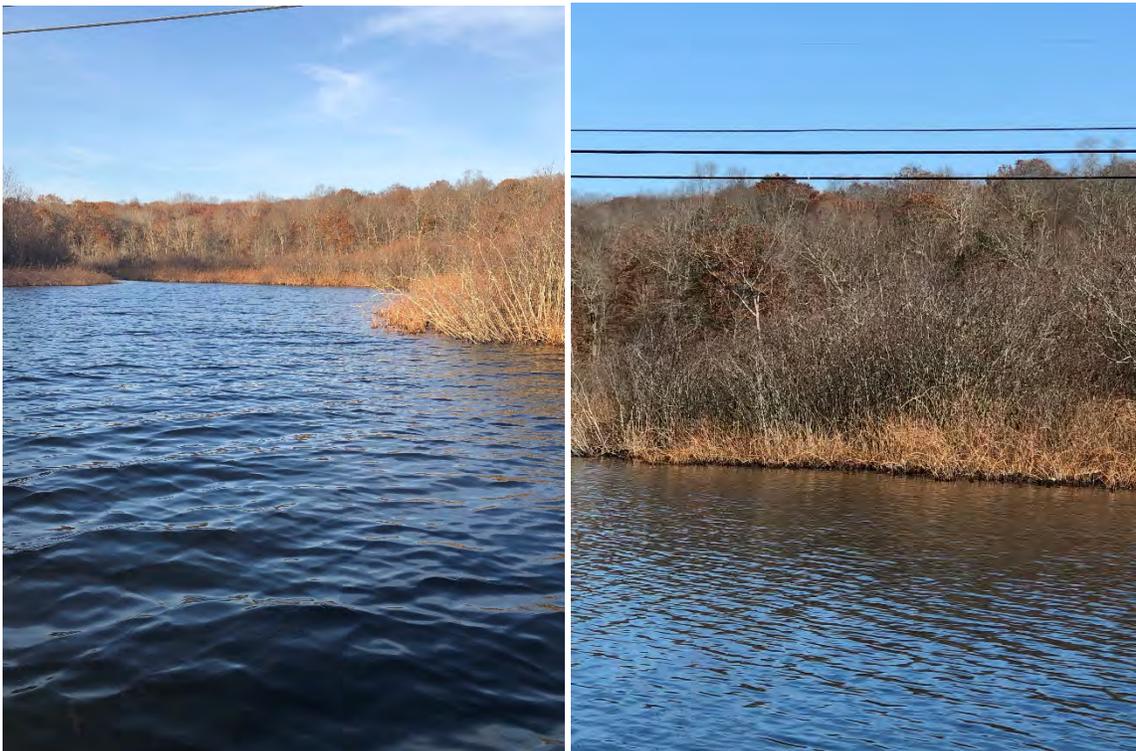
*Photos of the eastern inlet and wetland system of Lake Hayward*

The northern portion of the lake perimeter as well as a large wetland system on the eastern side of the lake support large wetland systems. The photos below show the eastern wetland. These photos were taken in the late fall.

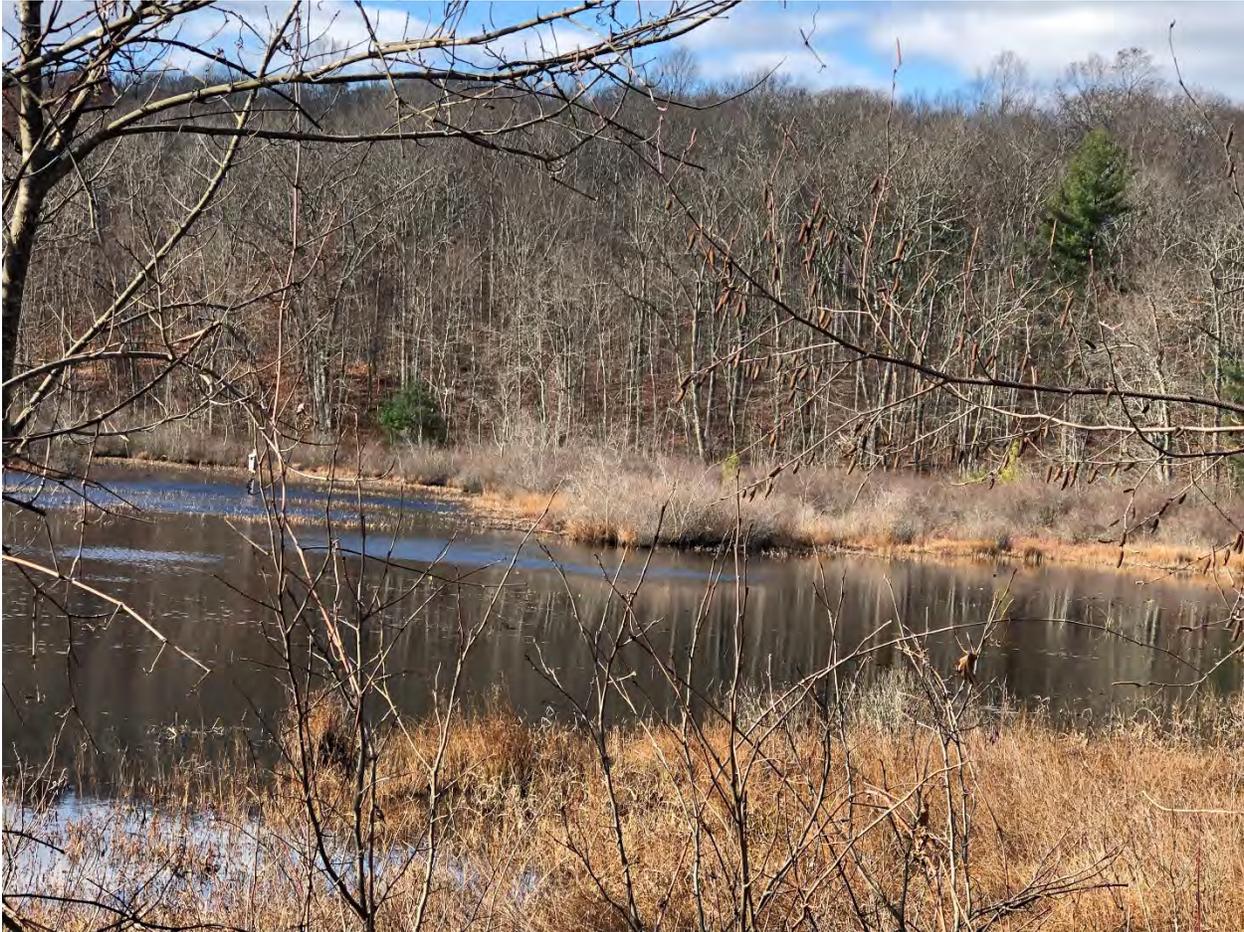
*Photo of the northern inlet and fen wetland system of Lake Hayward*

The most extensive wetland area occurs at the northern inlet to the lake, which is bisected by Lake Shore Drive, which connects the upstream and downstream ends with a single culvert.
